Manson Roofing Inc

INSPECTION REPORT

Riverview Condo

1400 1st Ave W, Bradenton

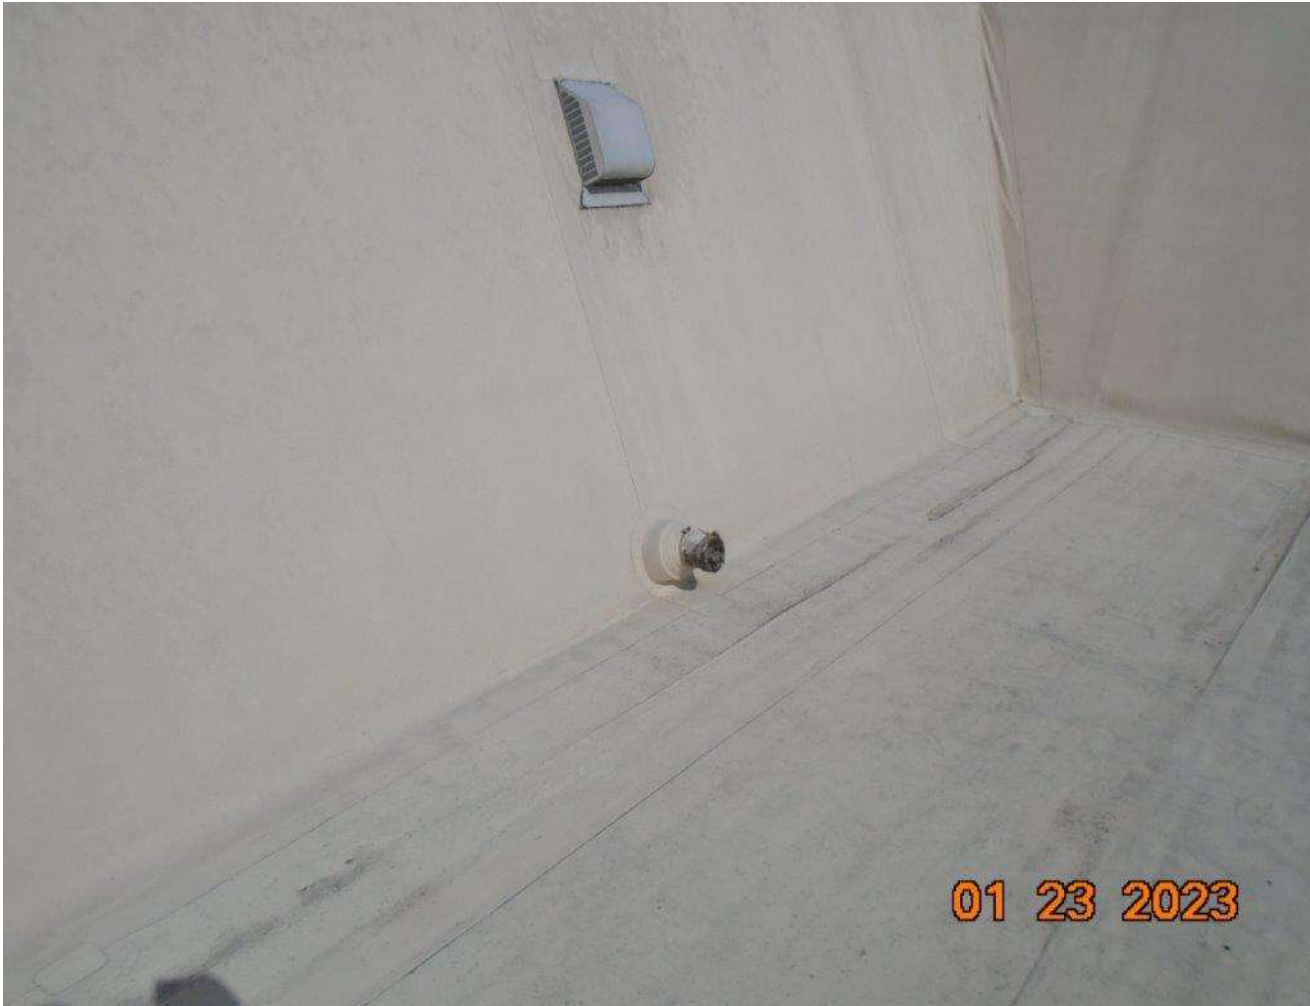
Observation

This is a picture of the walls, a mansard vent and an overflow scupper. They all appear to be in good condition.

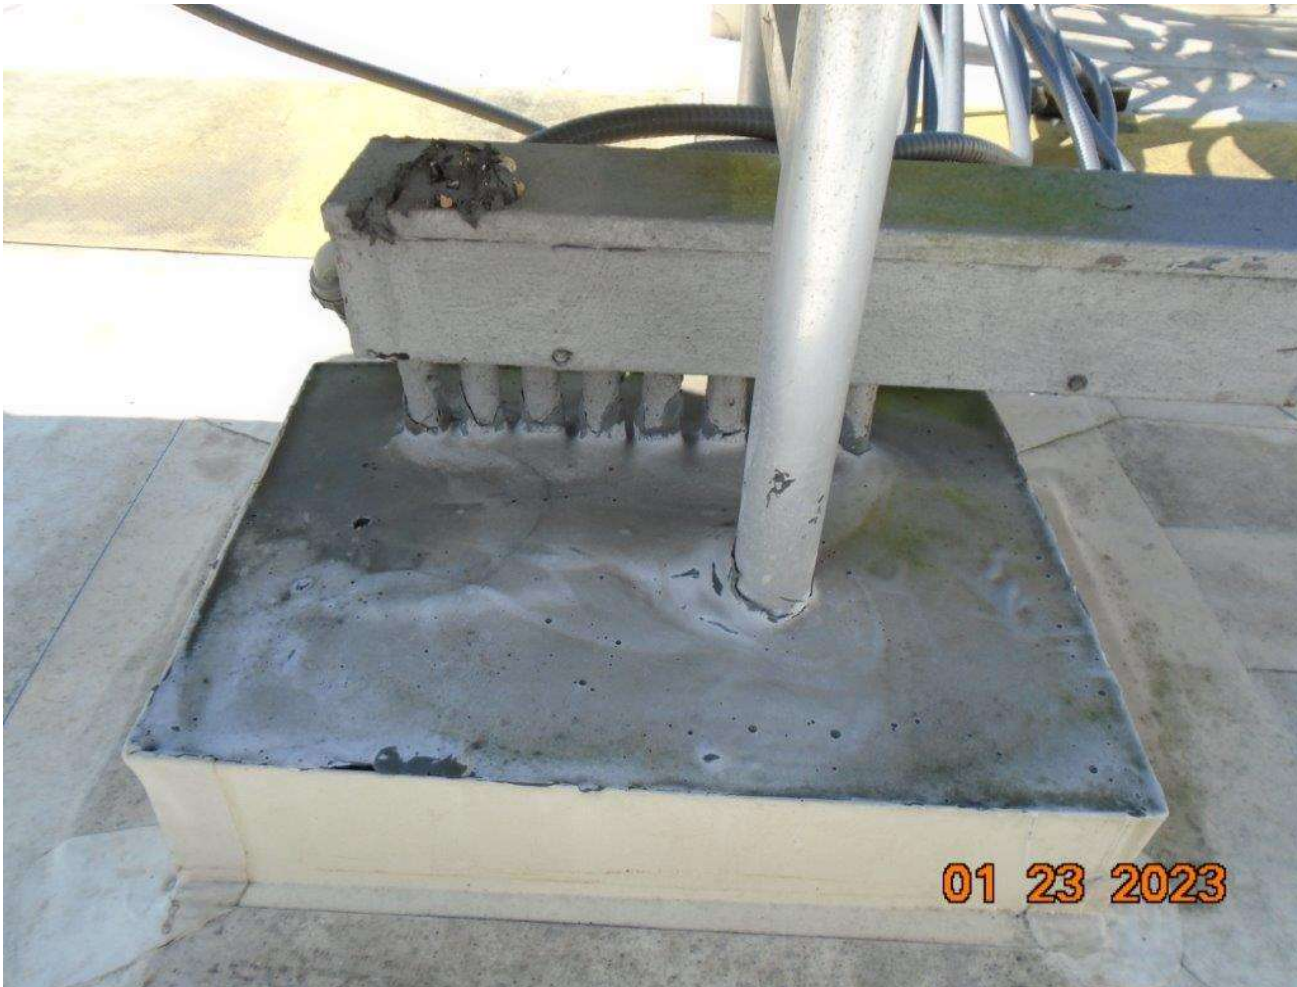
Observation

Pitch pans should be topped off and sealed with silicone.

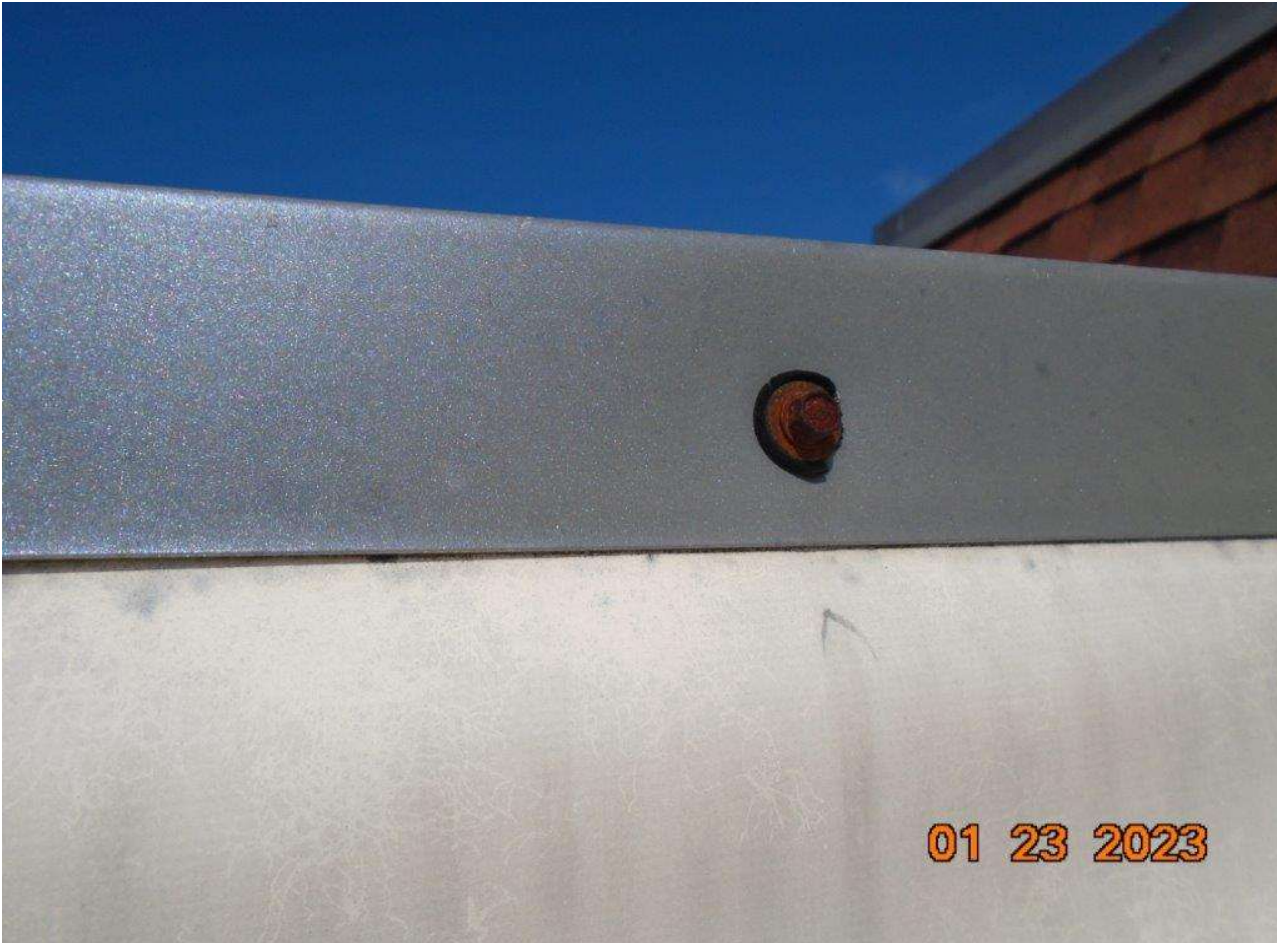
Observation

There are rusted fasteners at the coping that should be replaced.

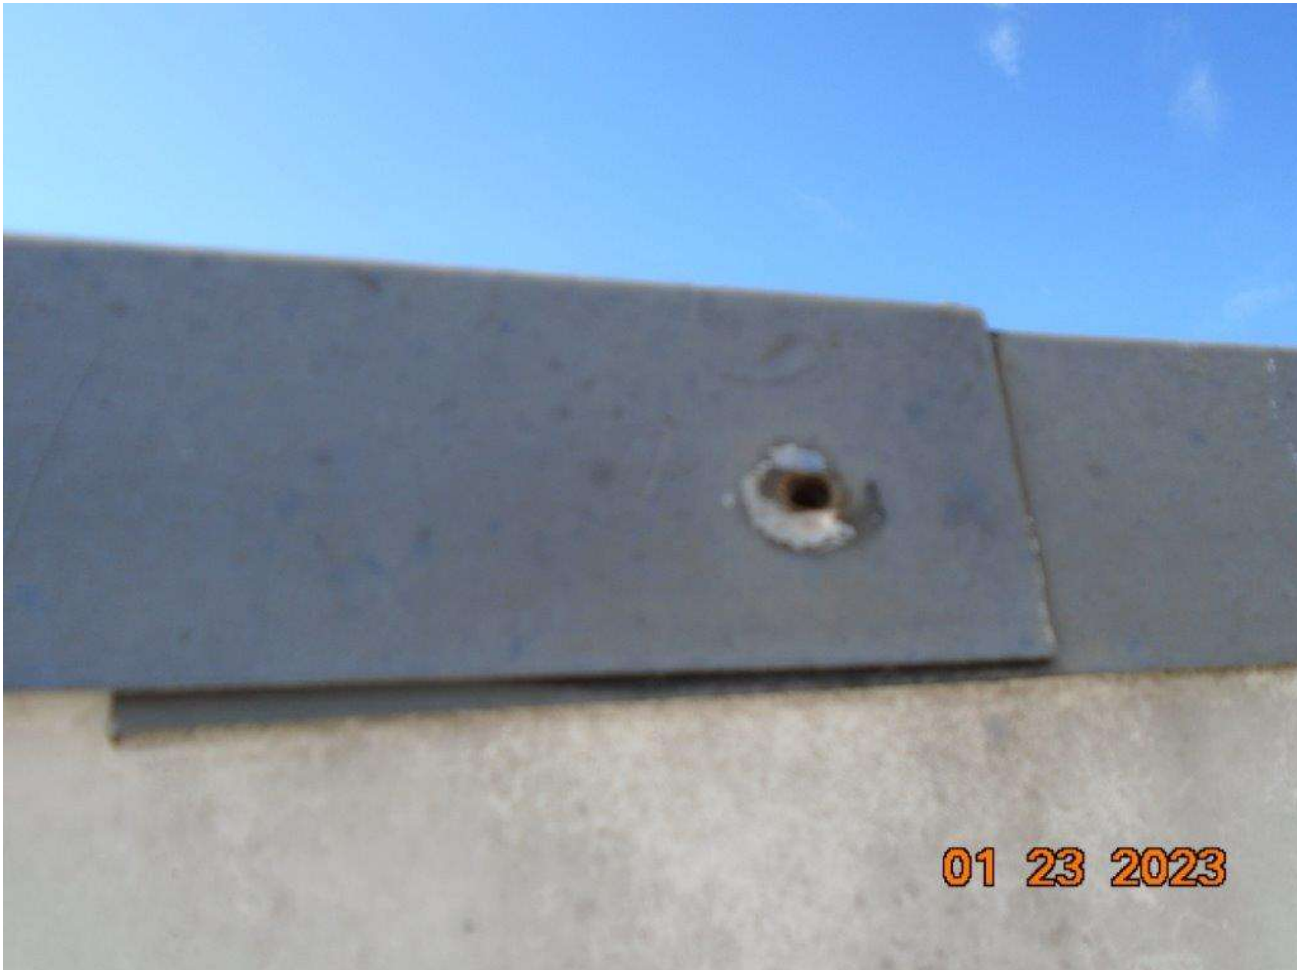
Observation

There are missing fasteners at the coping that should be replaced.

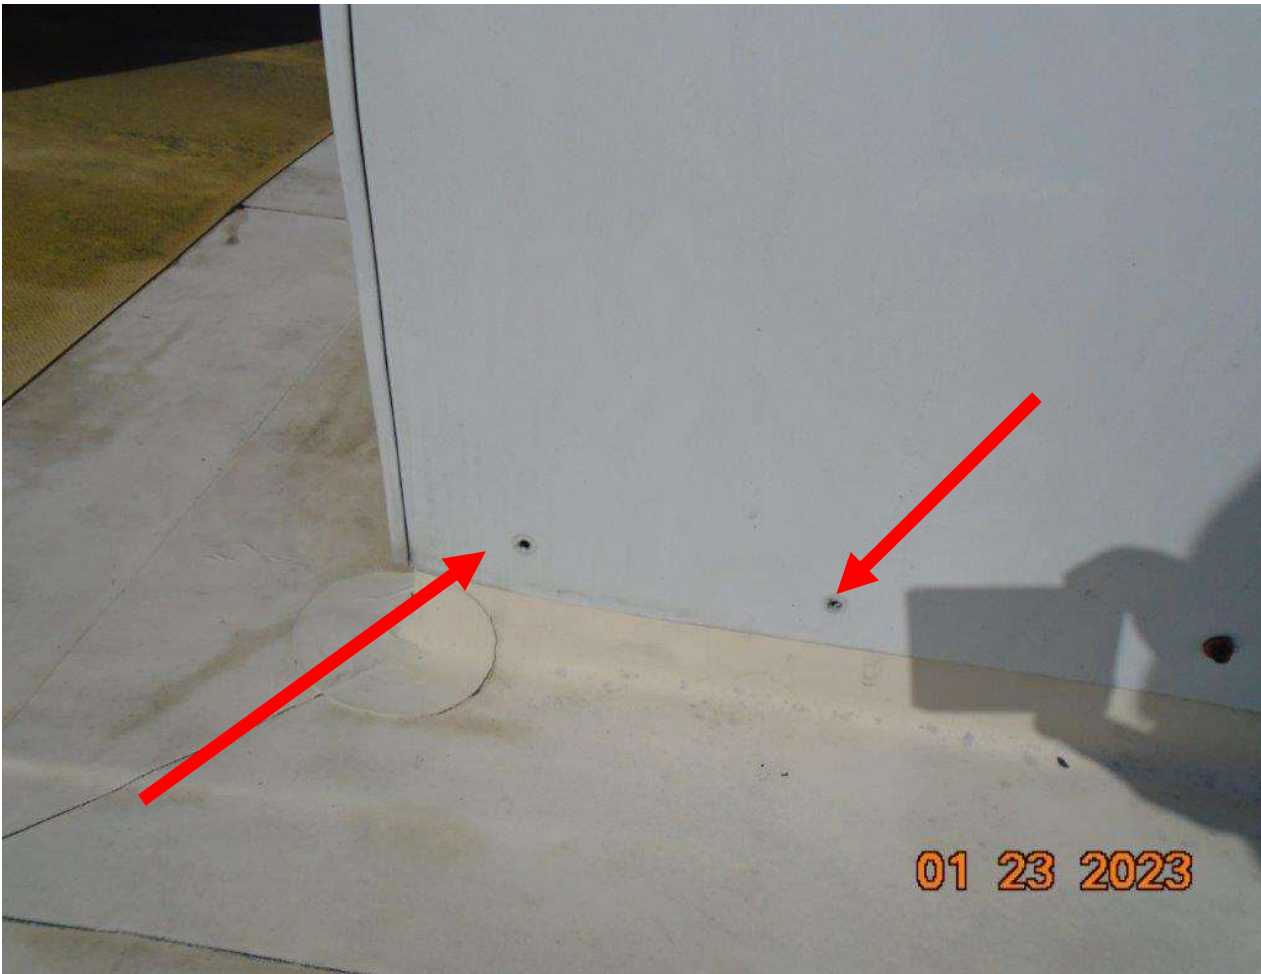
Observation

There are missing fasteners at hoods that should be replaced.

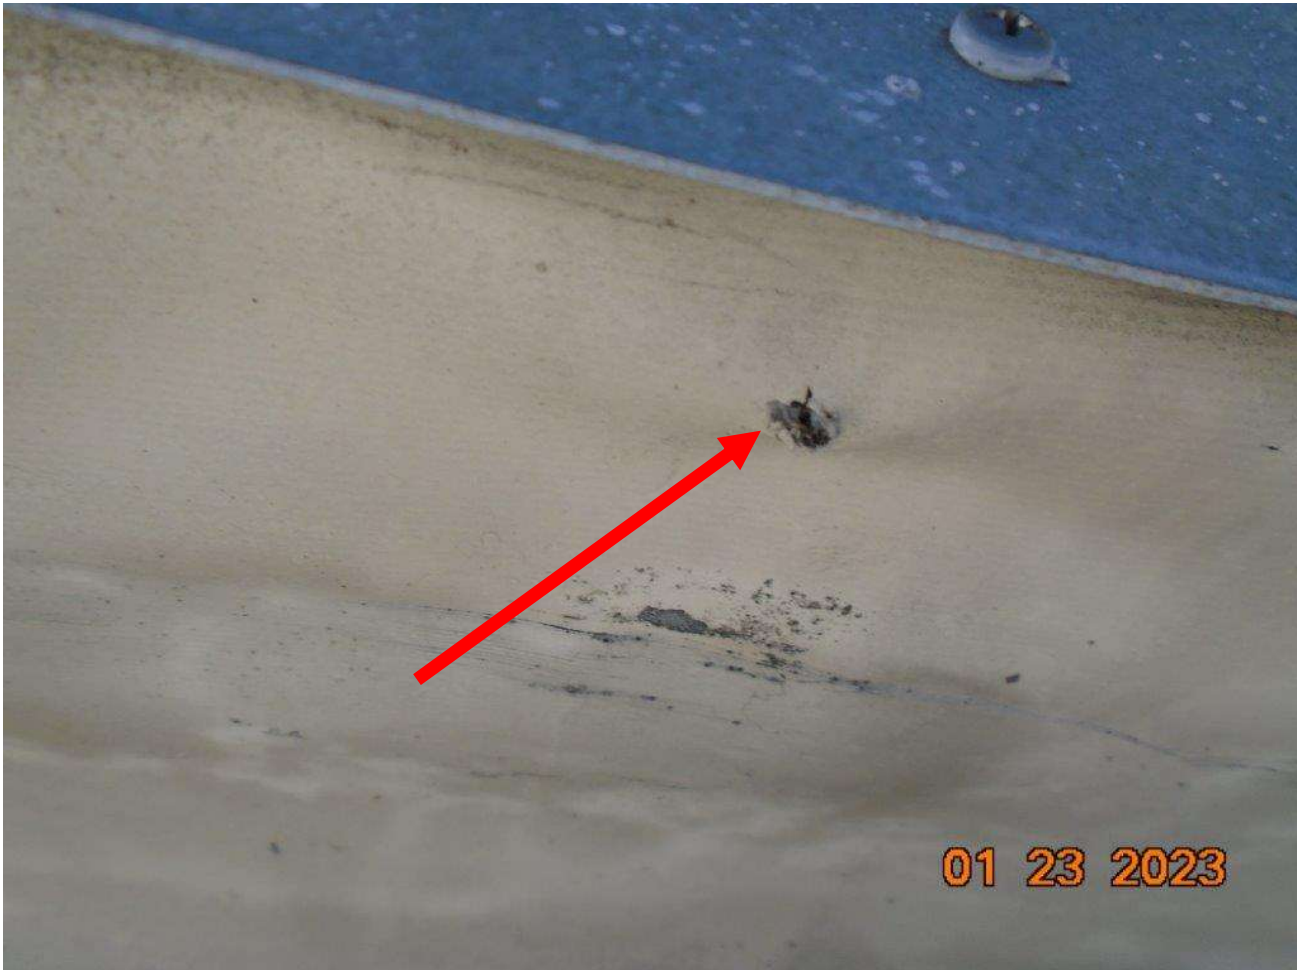
Observation

There are holes in the membrane where curbs have been removed and not put back in the same location.

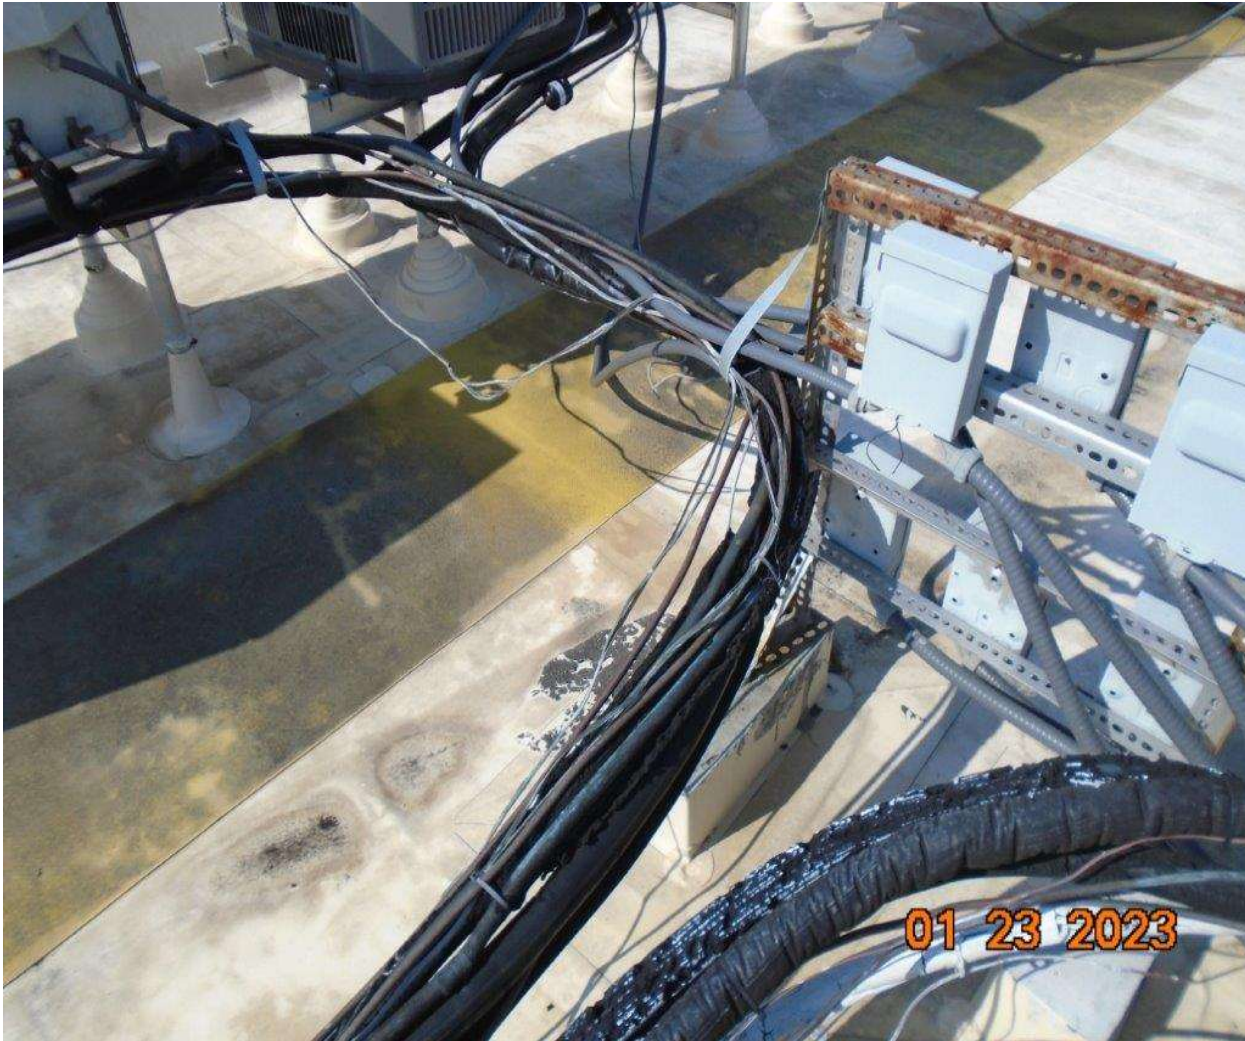
Observation

There is excessive deterioration of insulation at A/C lines.

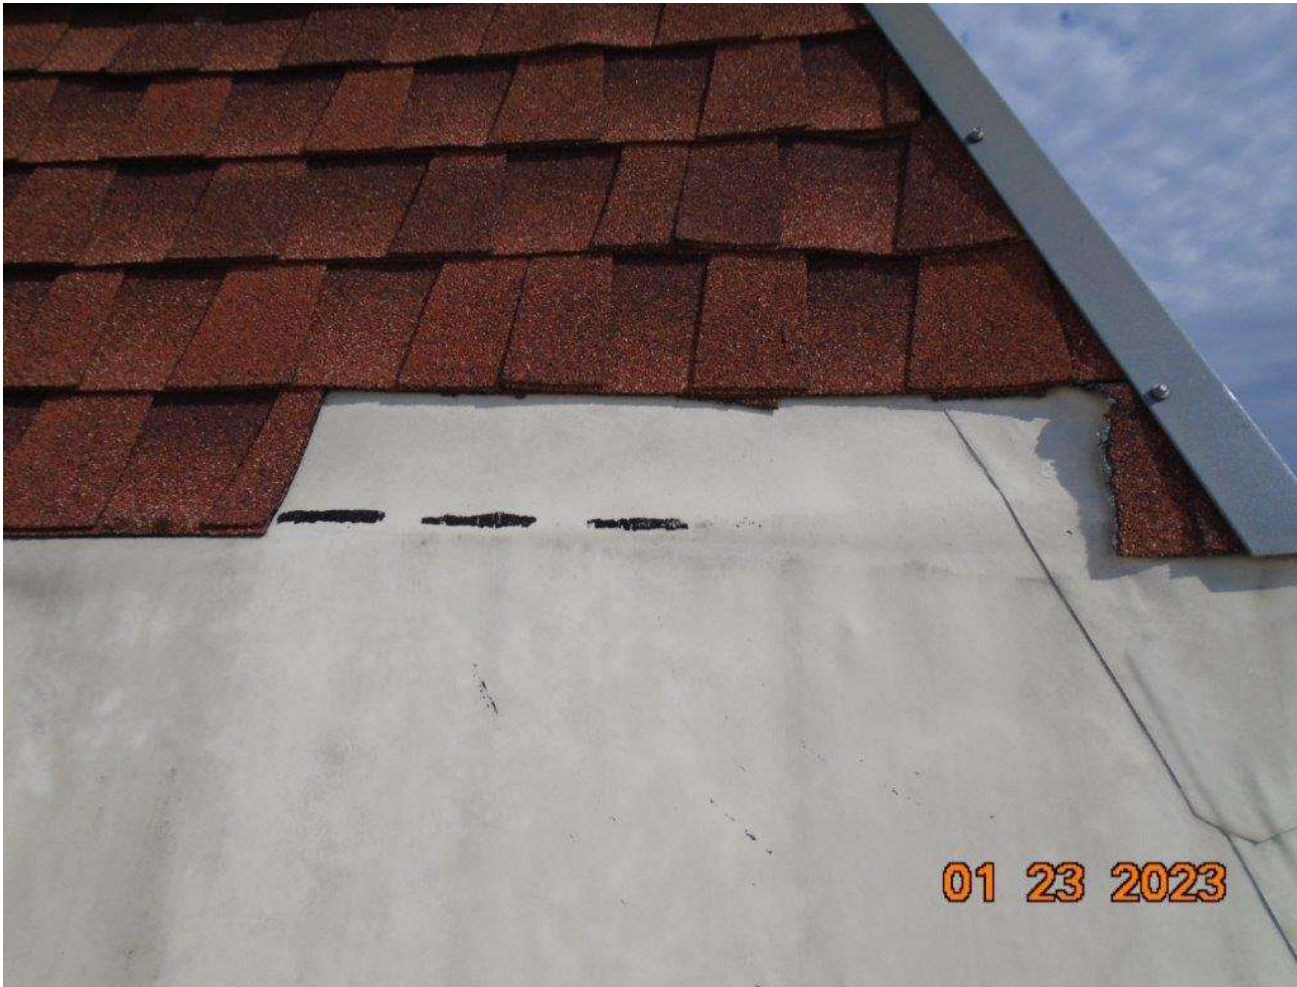
Observation

There are missing shingles that need to be replaced.

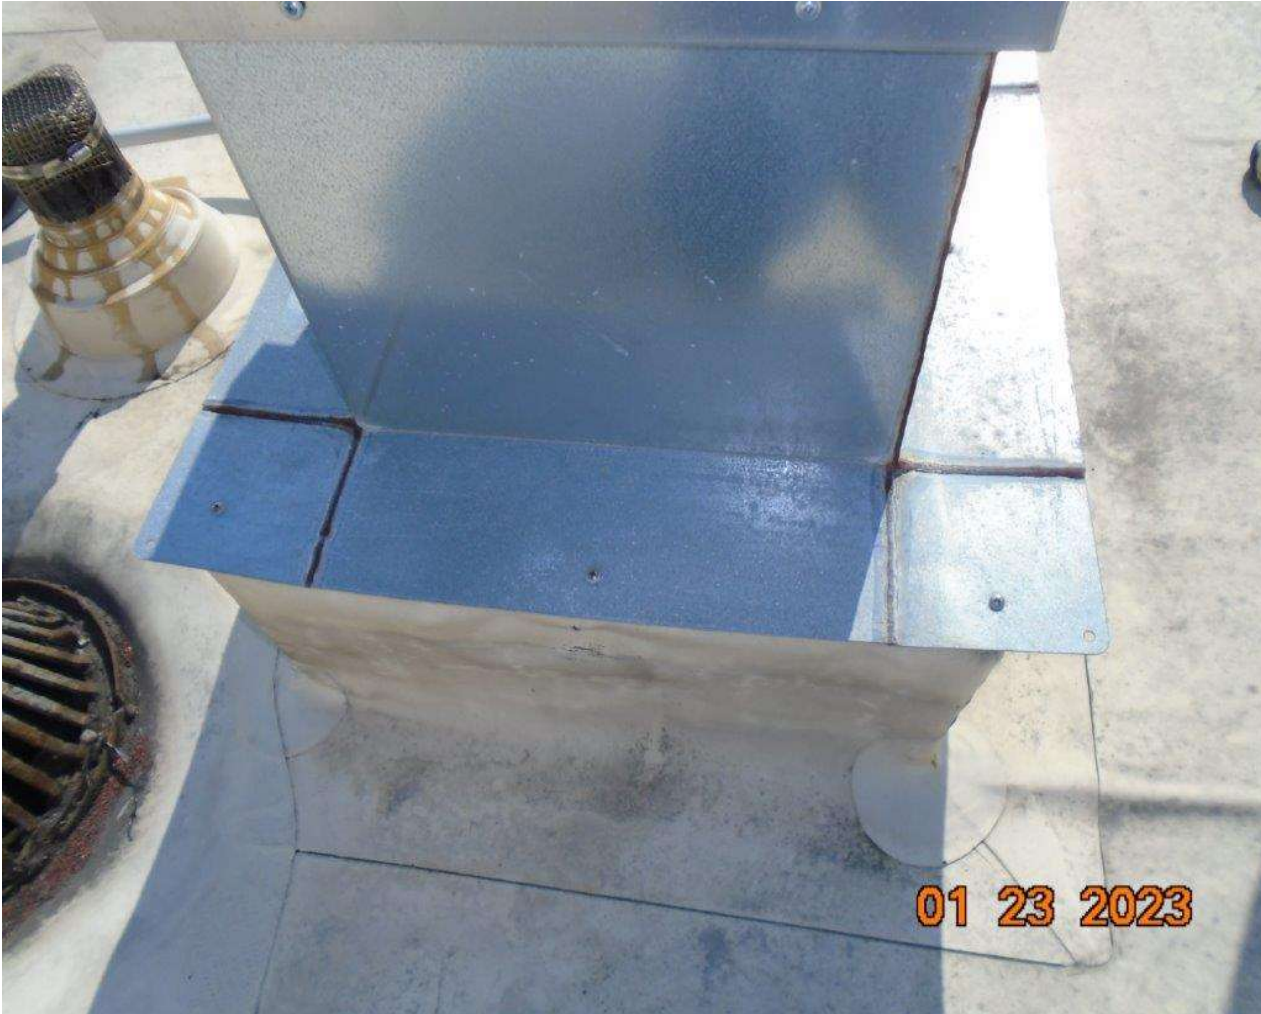
Observation
There is an improperly installed exhaust vent.

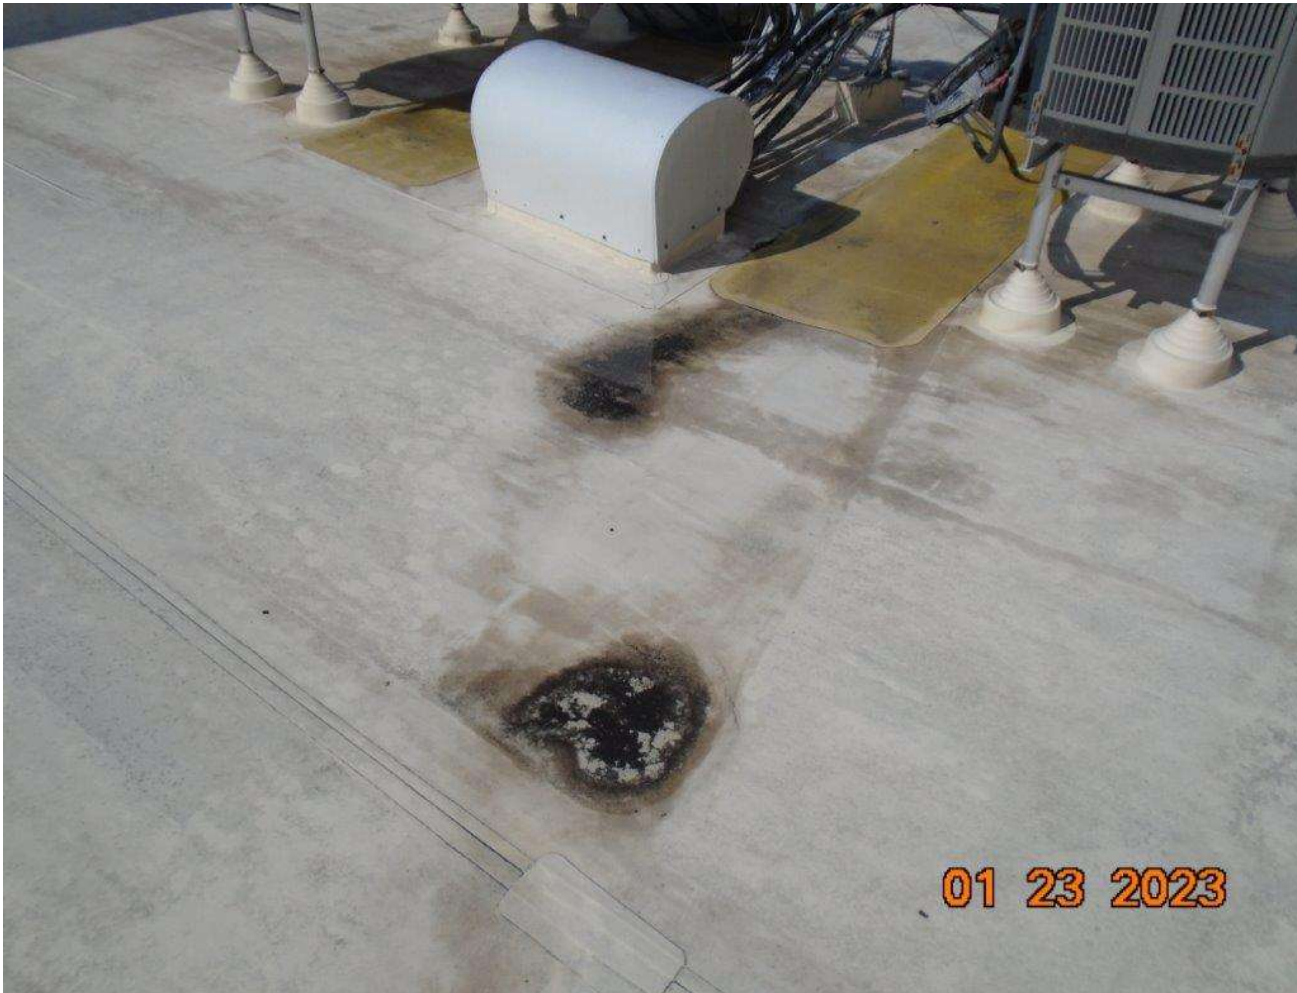
Deficiency

Areas of the roof needs to be cleaned.

Solution

Need to clean heavily soiled areas of the roof with low pressure wash, approved cleaner, and a soft bristle brush.
