PHASE I MILESTONE INSPECTION

The Riverview Condominium Association, Inc.

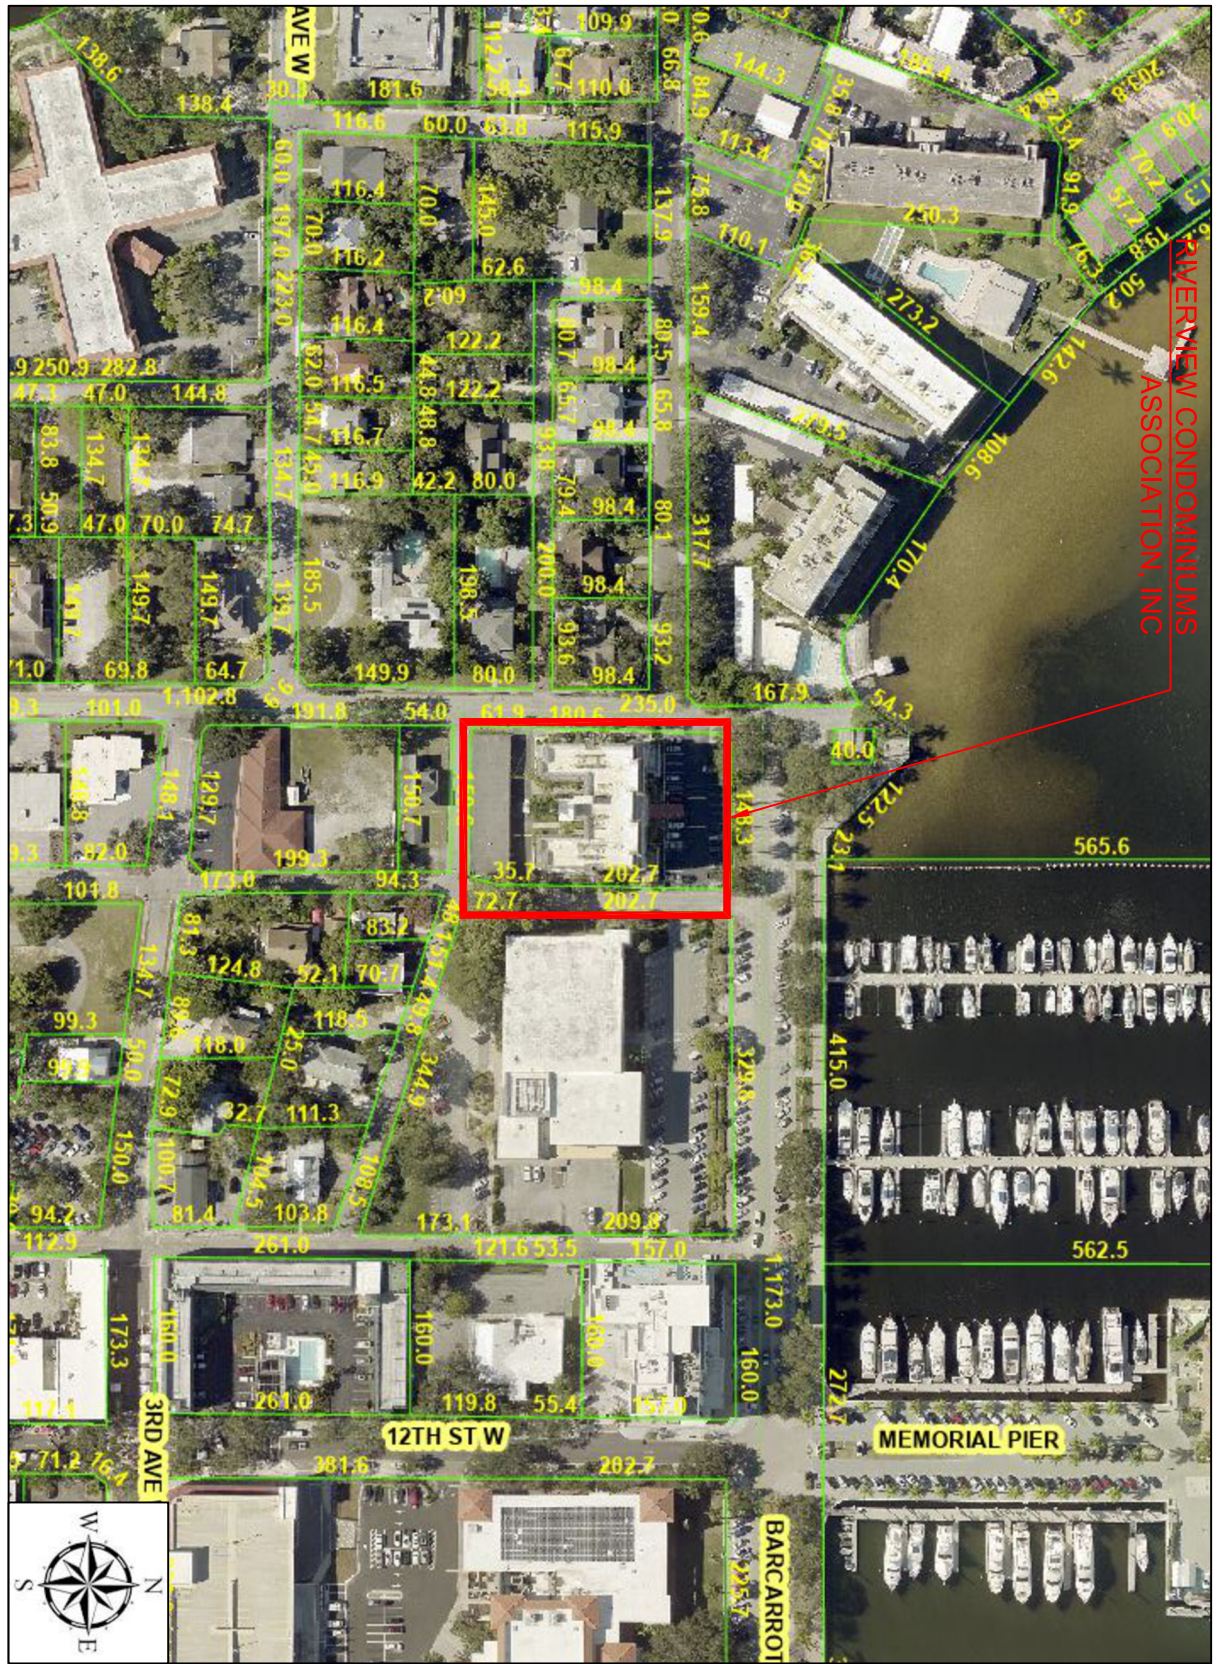
APPENDIX B
SITE PHOTOGRAPHS

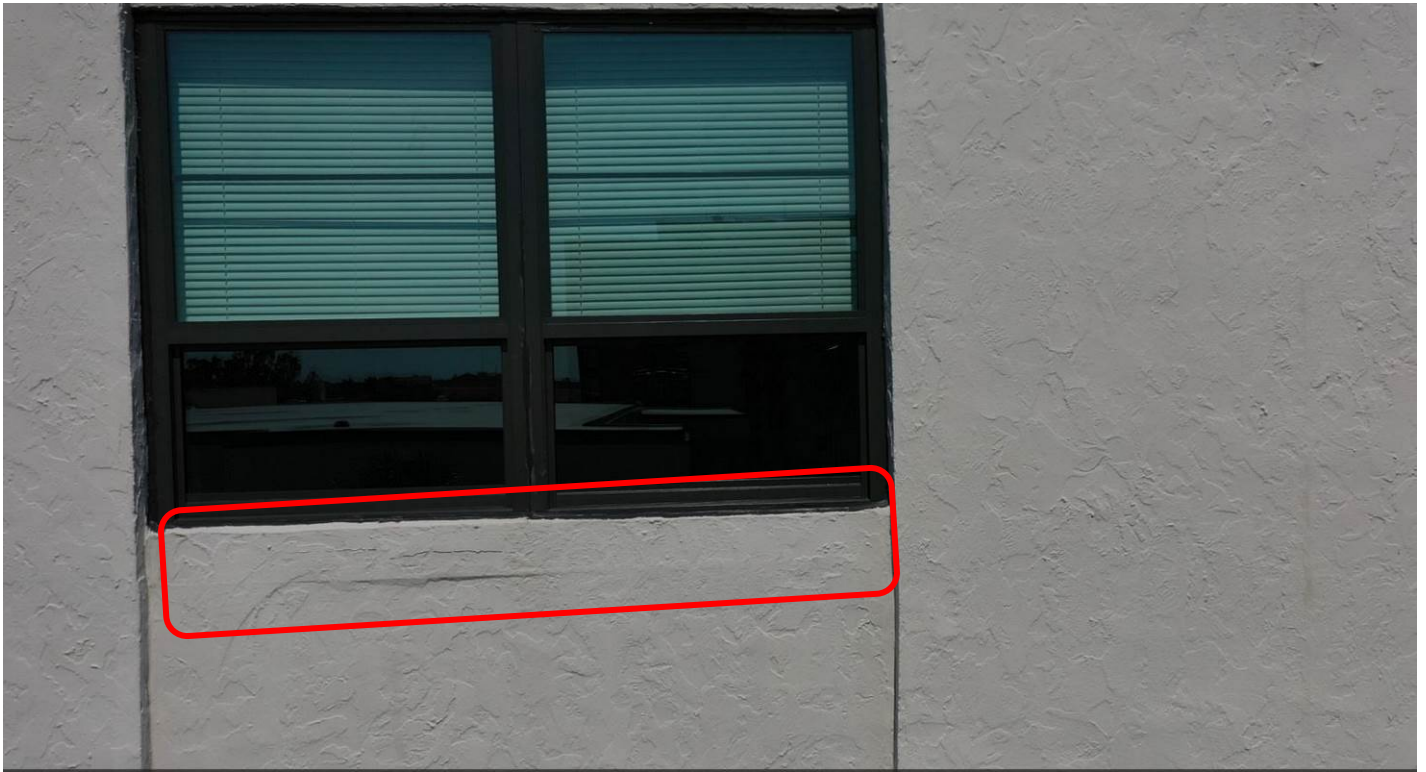
Photograph 5: East Elevation at 4th Level. 1st Window from North – Sample of Cracked Window's Sill.

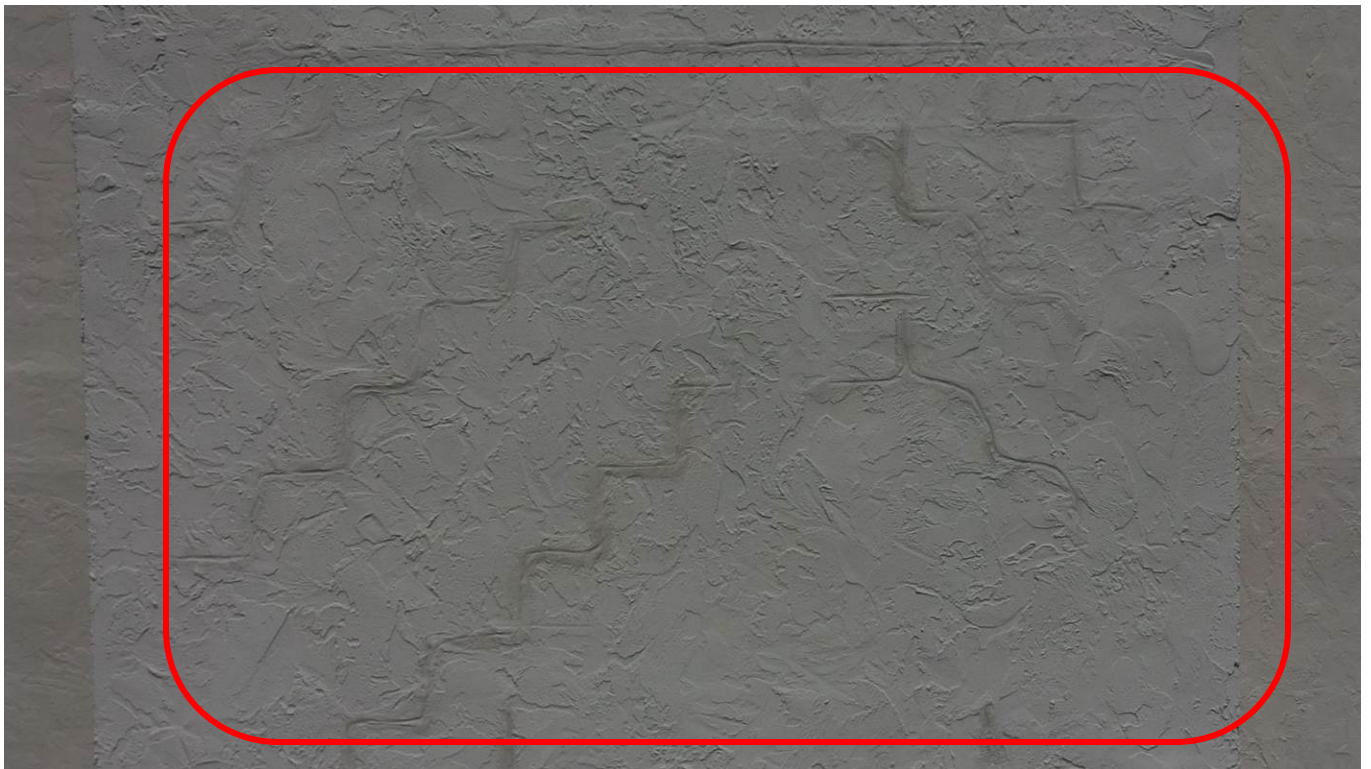
Photograph 6: East Stairwell's Wall at 6th Level – Sample of Stucco Crack with Signs of Moisture Inside.

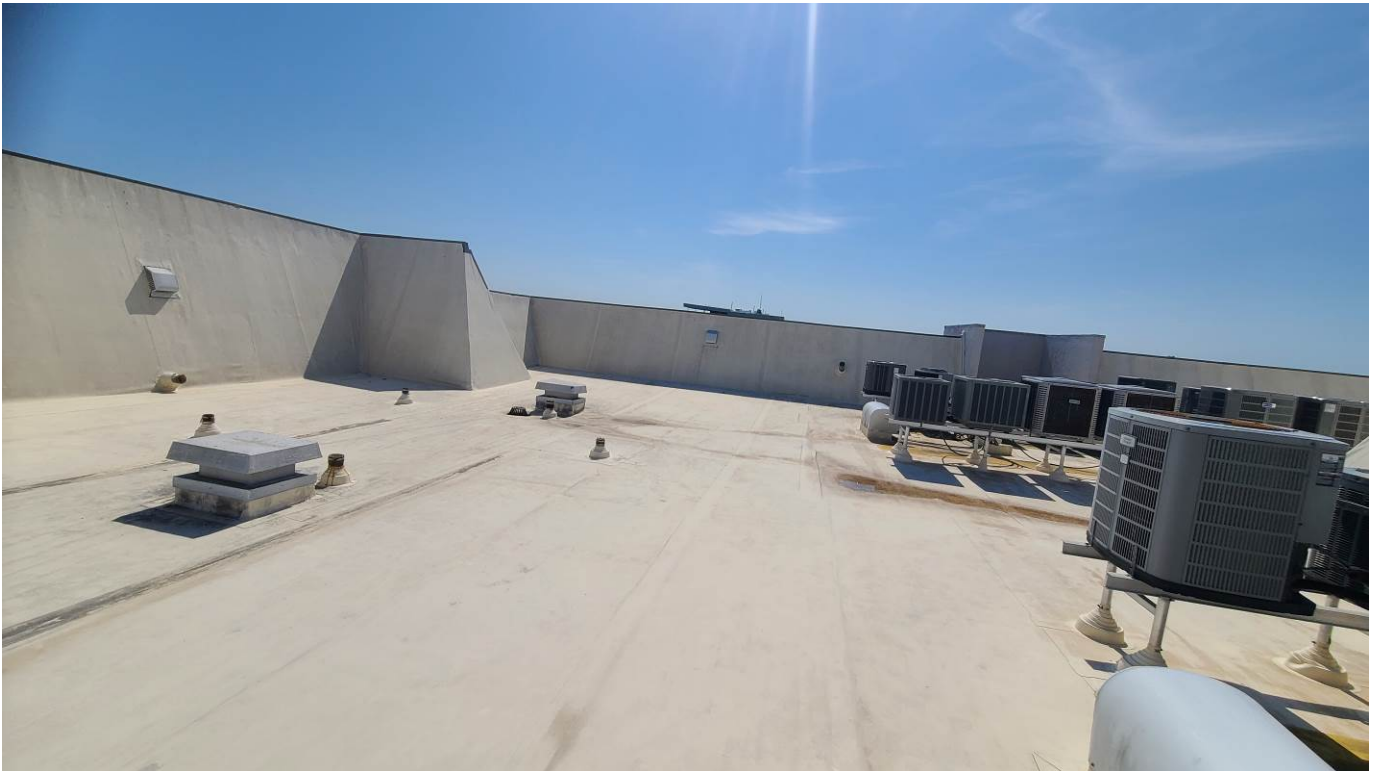
Photograph 8: The Roof, Current Condition.

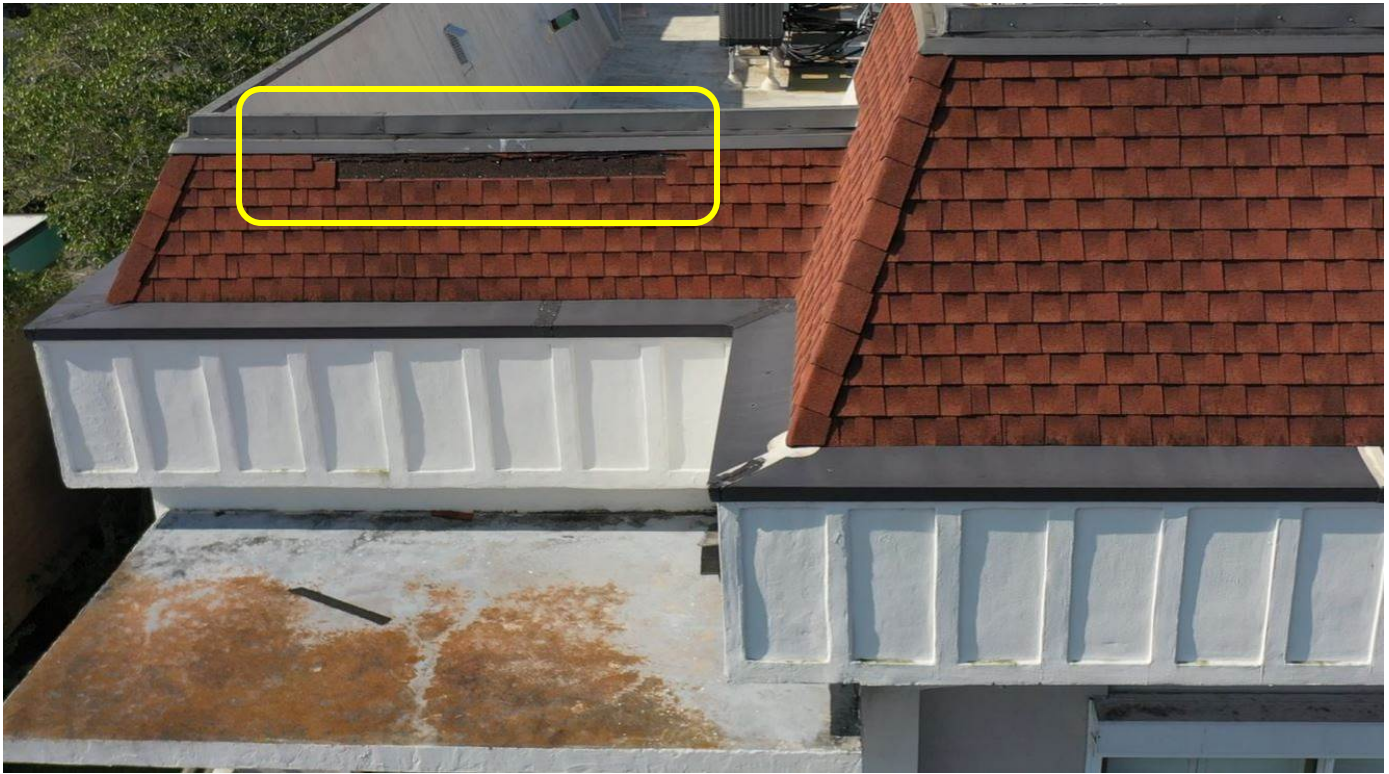
Photograph 11: Mansard Roof (Parapet) – Sample of Missing Shingles on Exterior Face.

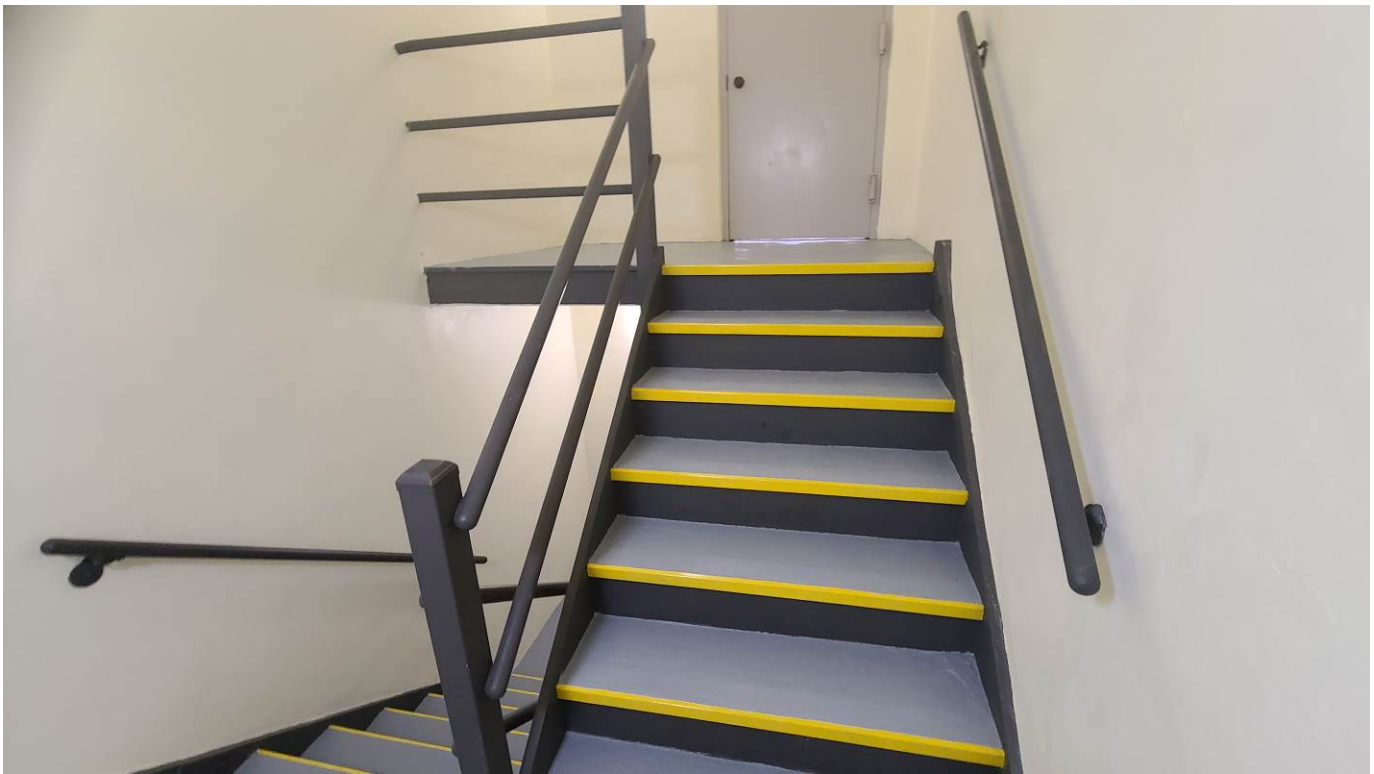
Photograph 12: East Stairwell – Current Condition.

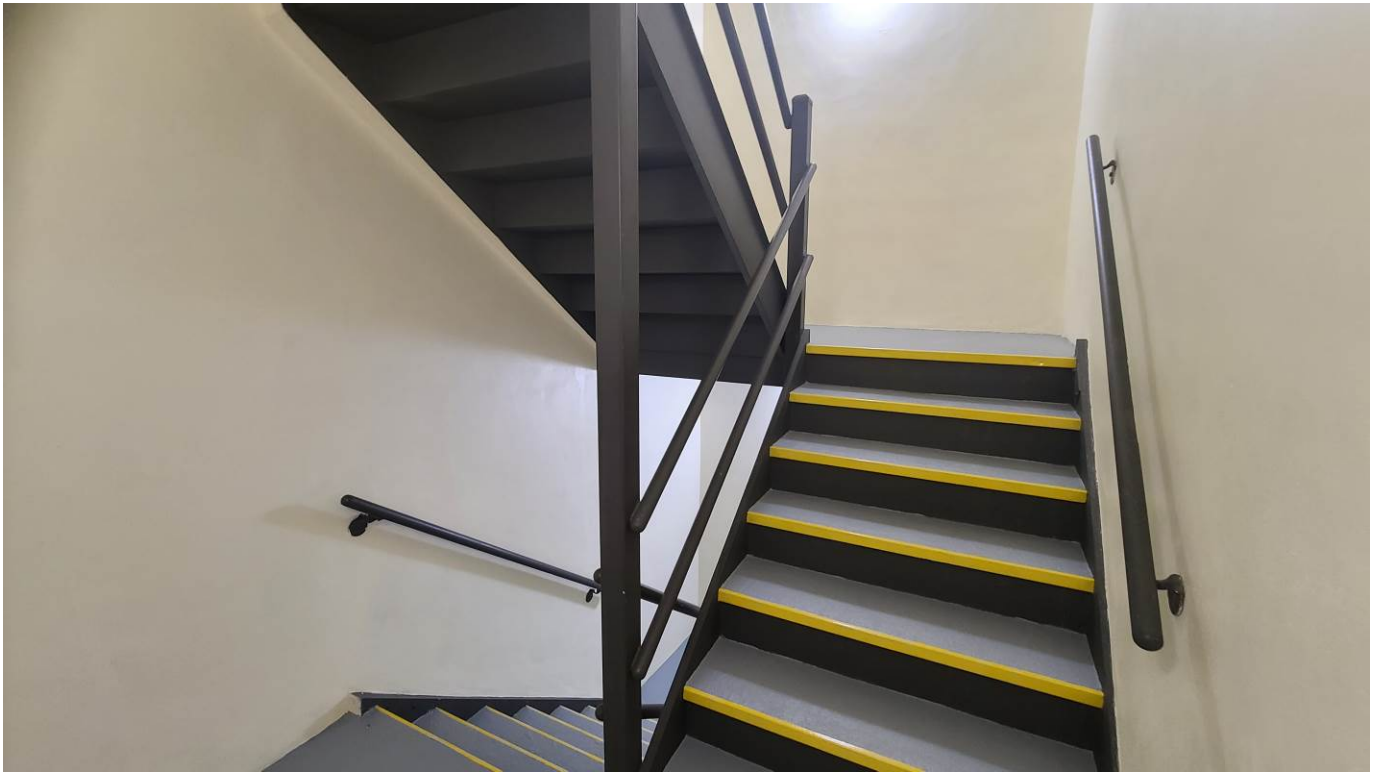
Photograph 13: East Stairwell – Current Condition.

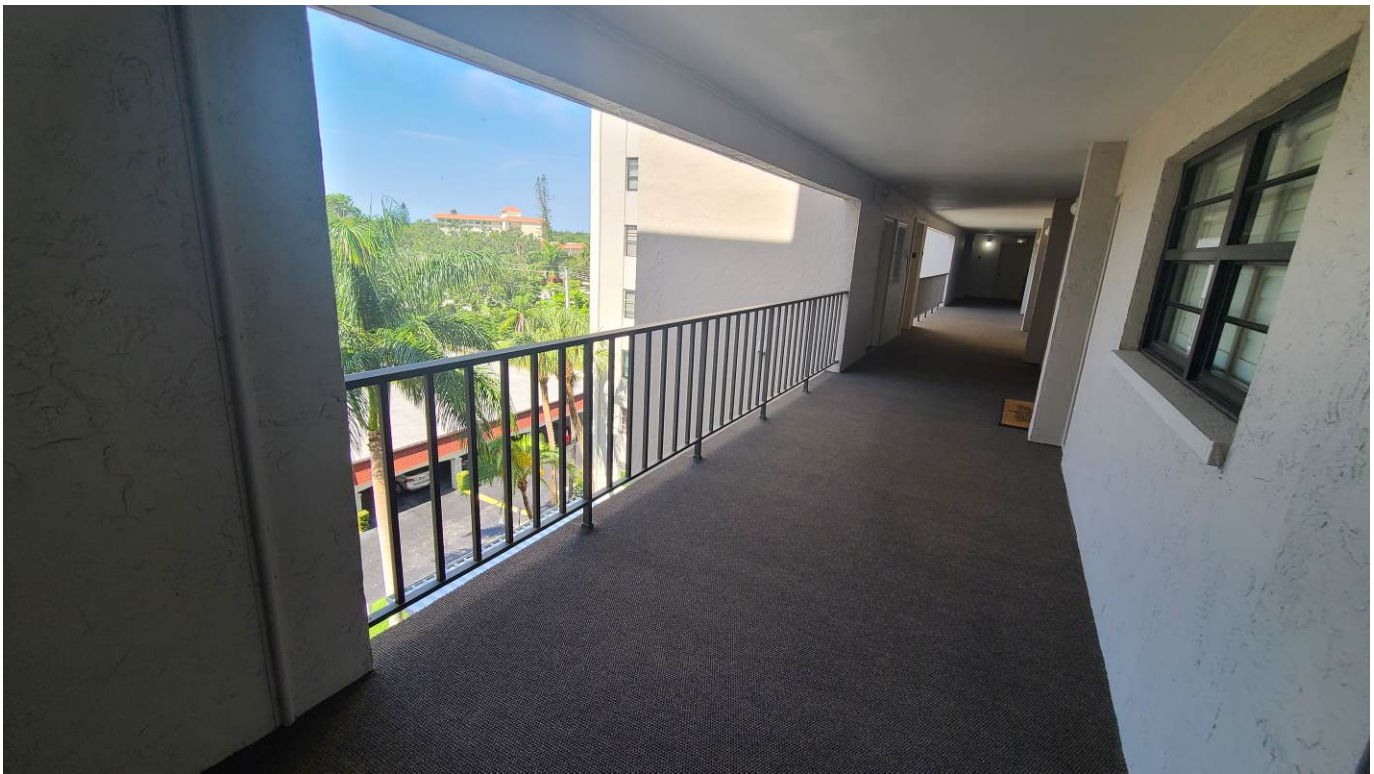
Photograph 14: Building Walkways – Current Condition.

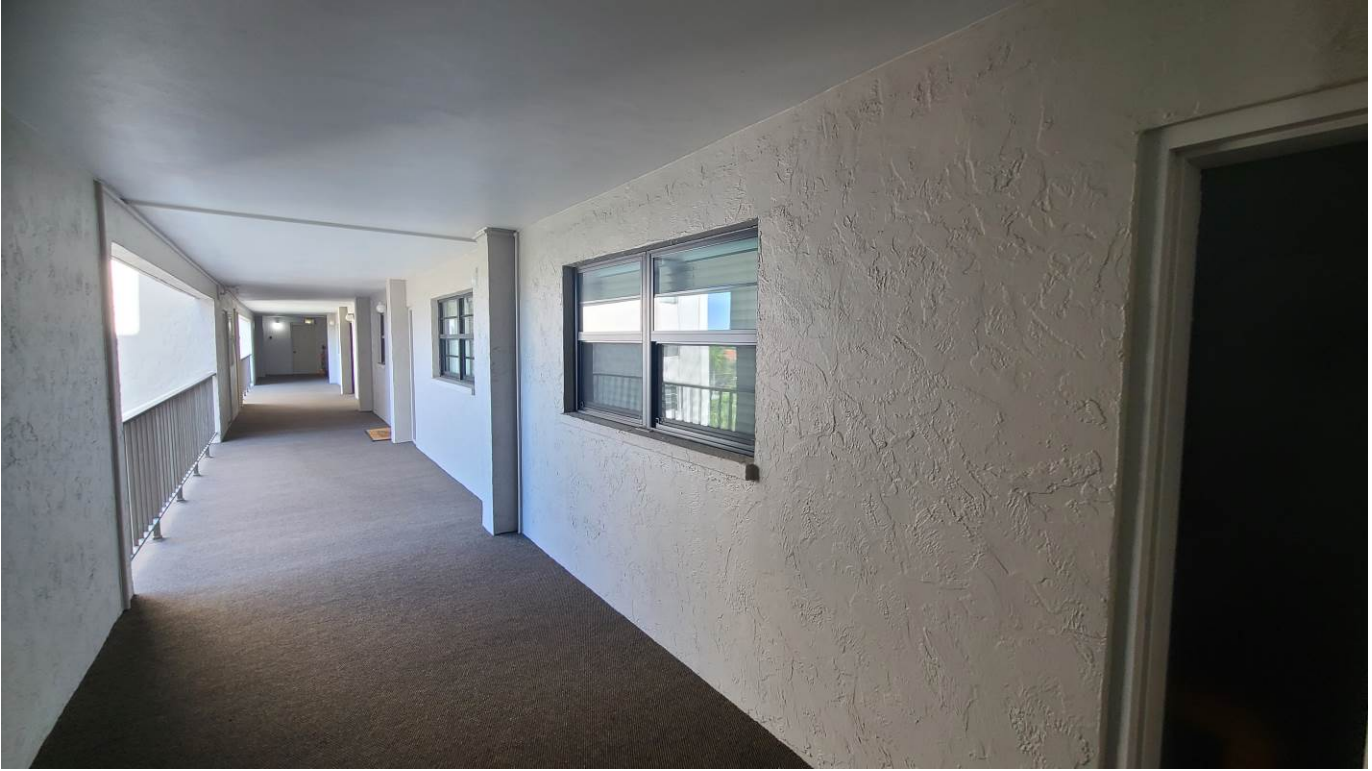
Photograph 15: Building Walkways – Current Condition.

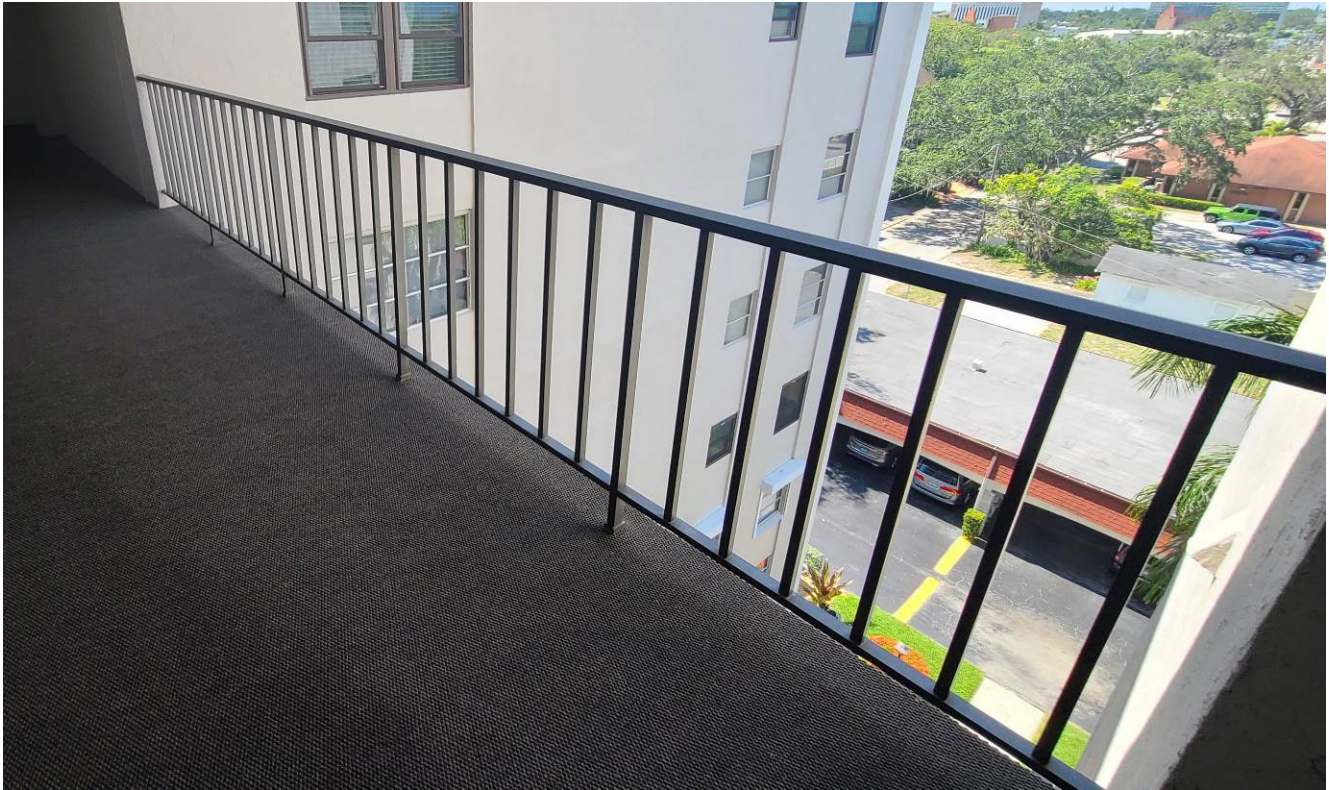
Photograph 16: Typical Walkway Guards. Guards are Mechanically Fastened Members, Core Mounted Posts. Guards Dimensions Do Not Comply with the Applicable Building Code

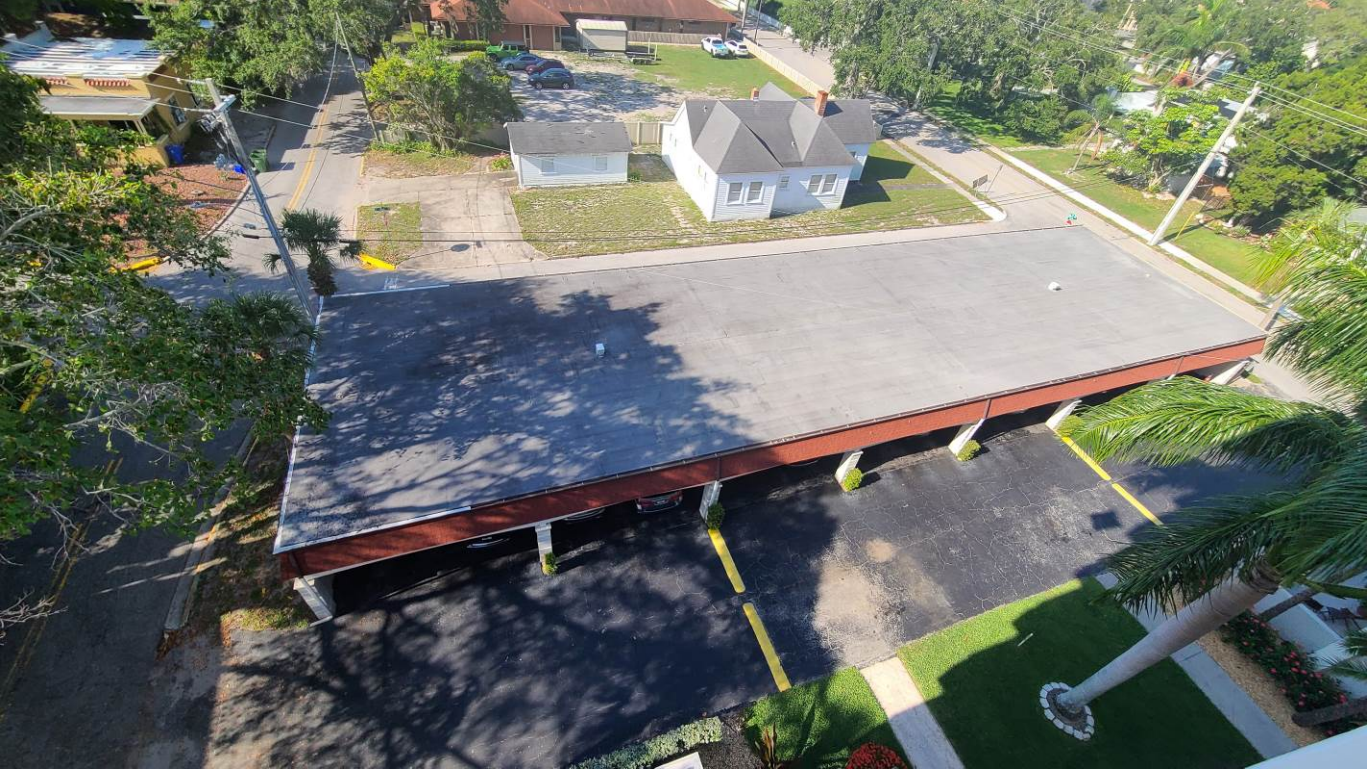
Photograph 22: Building Common Areas – Carport

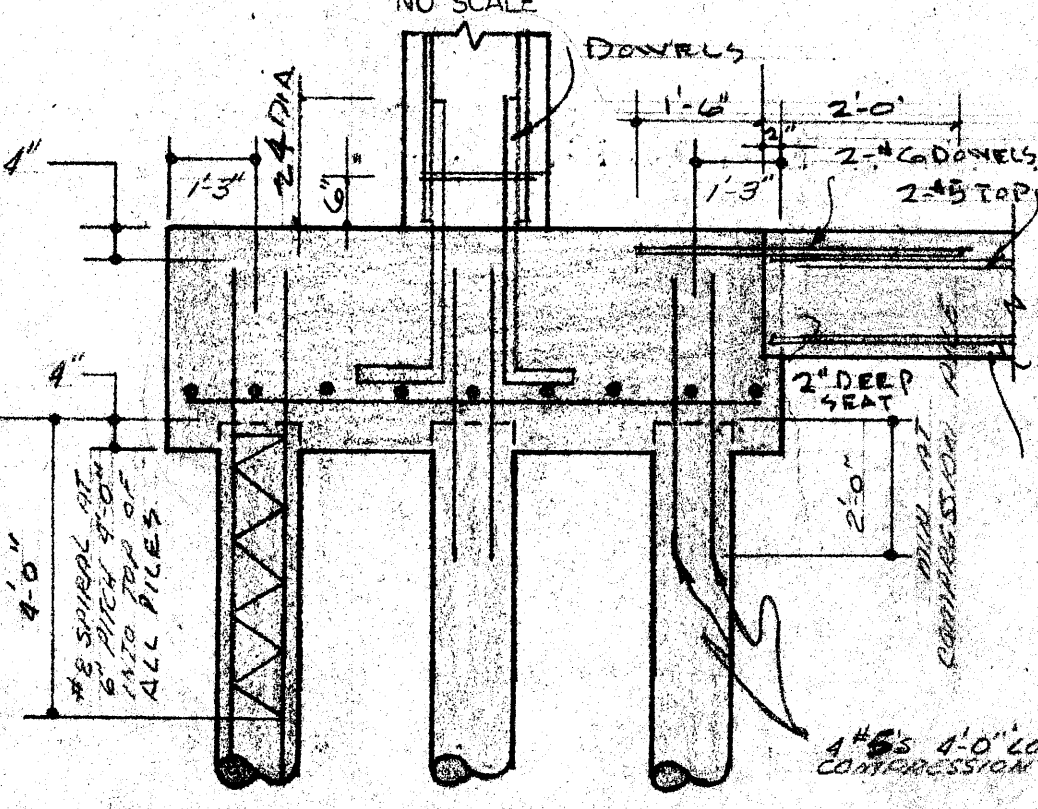
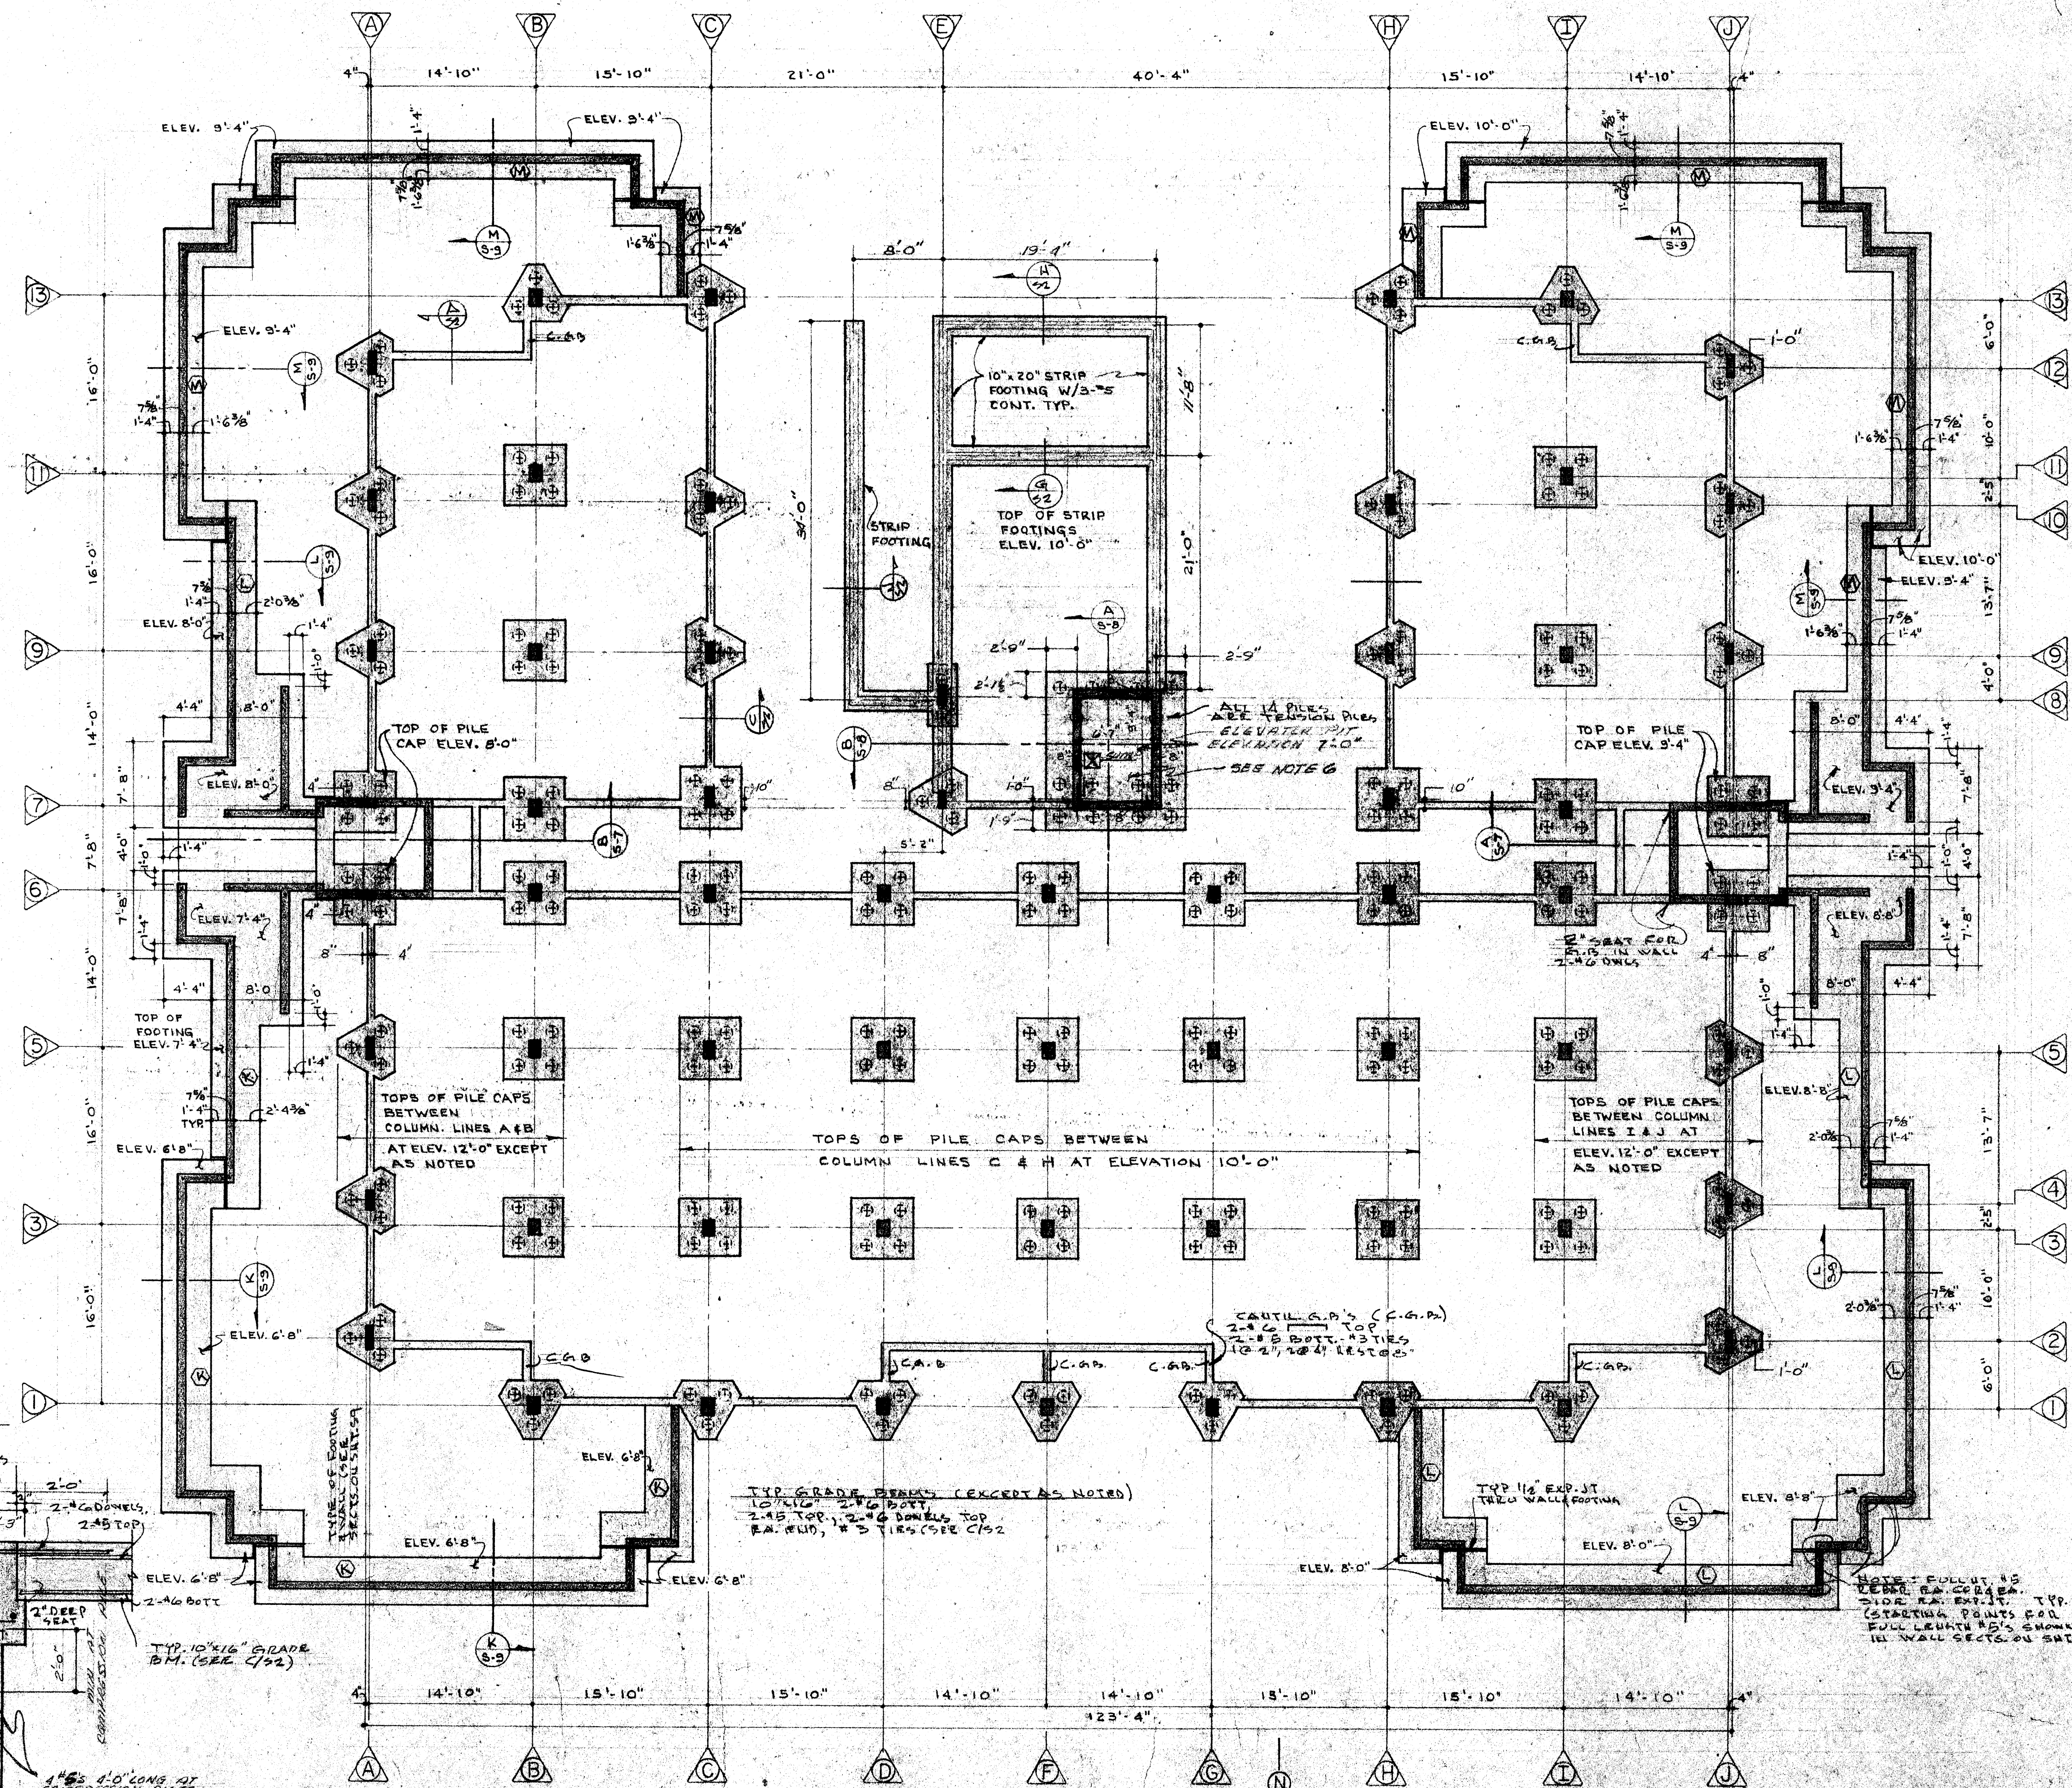
FOUNDATION PLAN
 SCALE 1/8" = 1'-0"

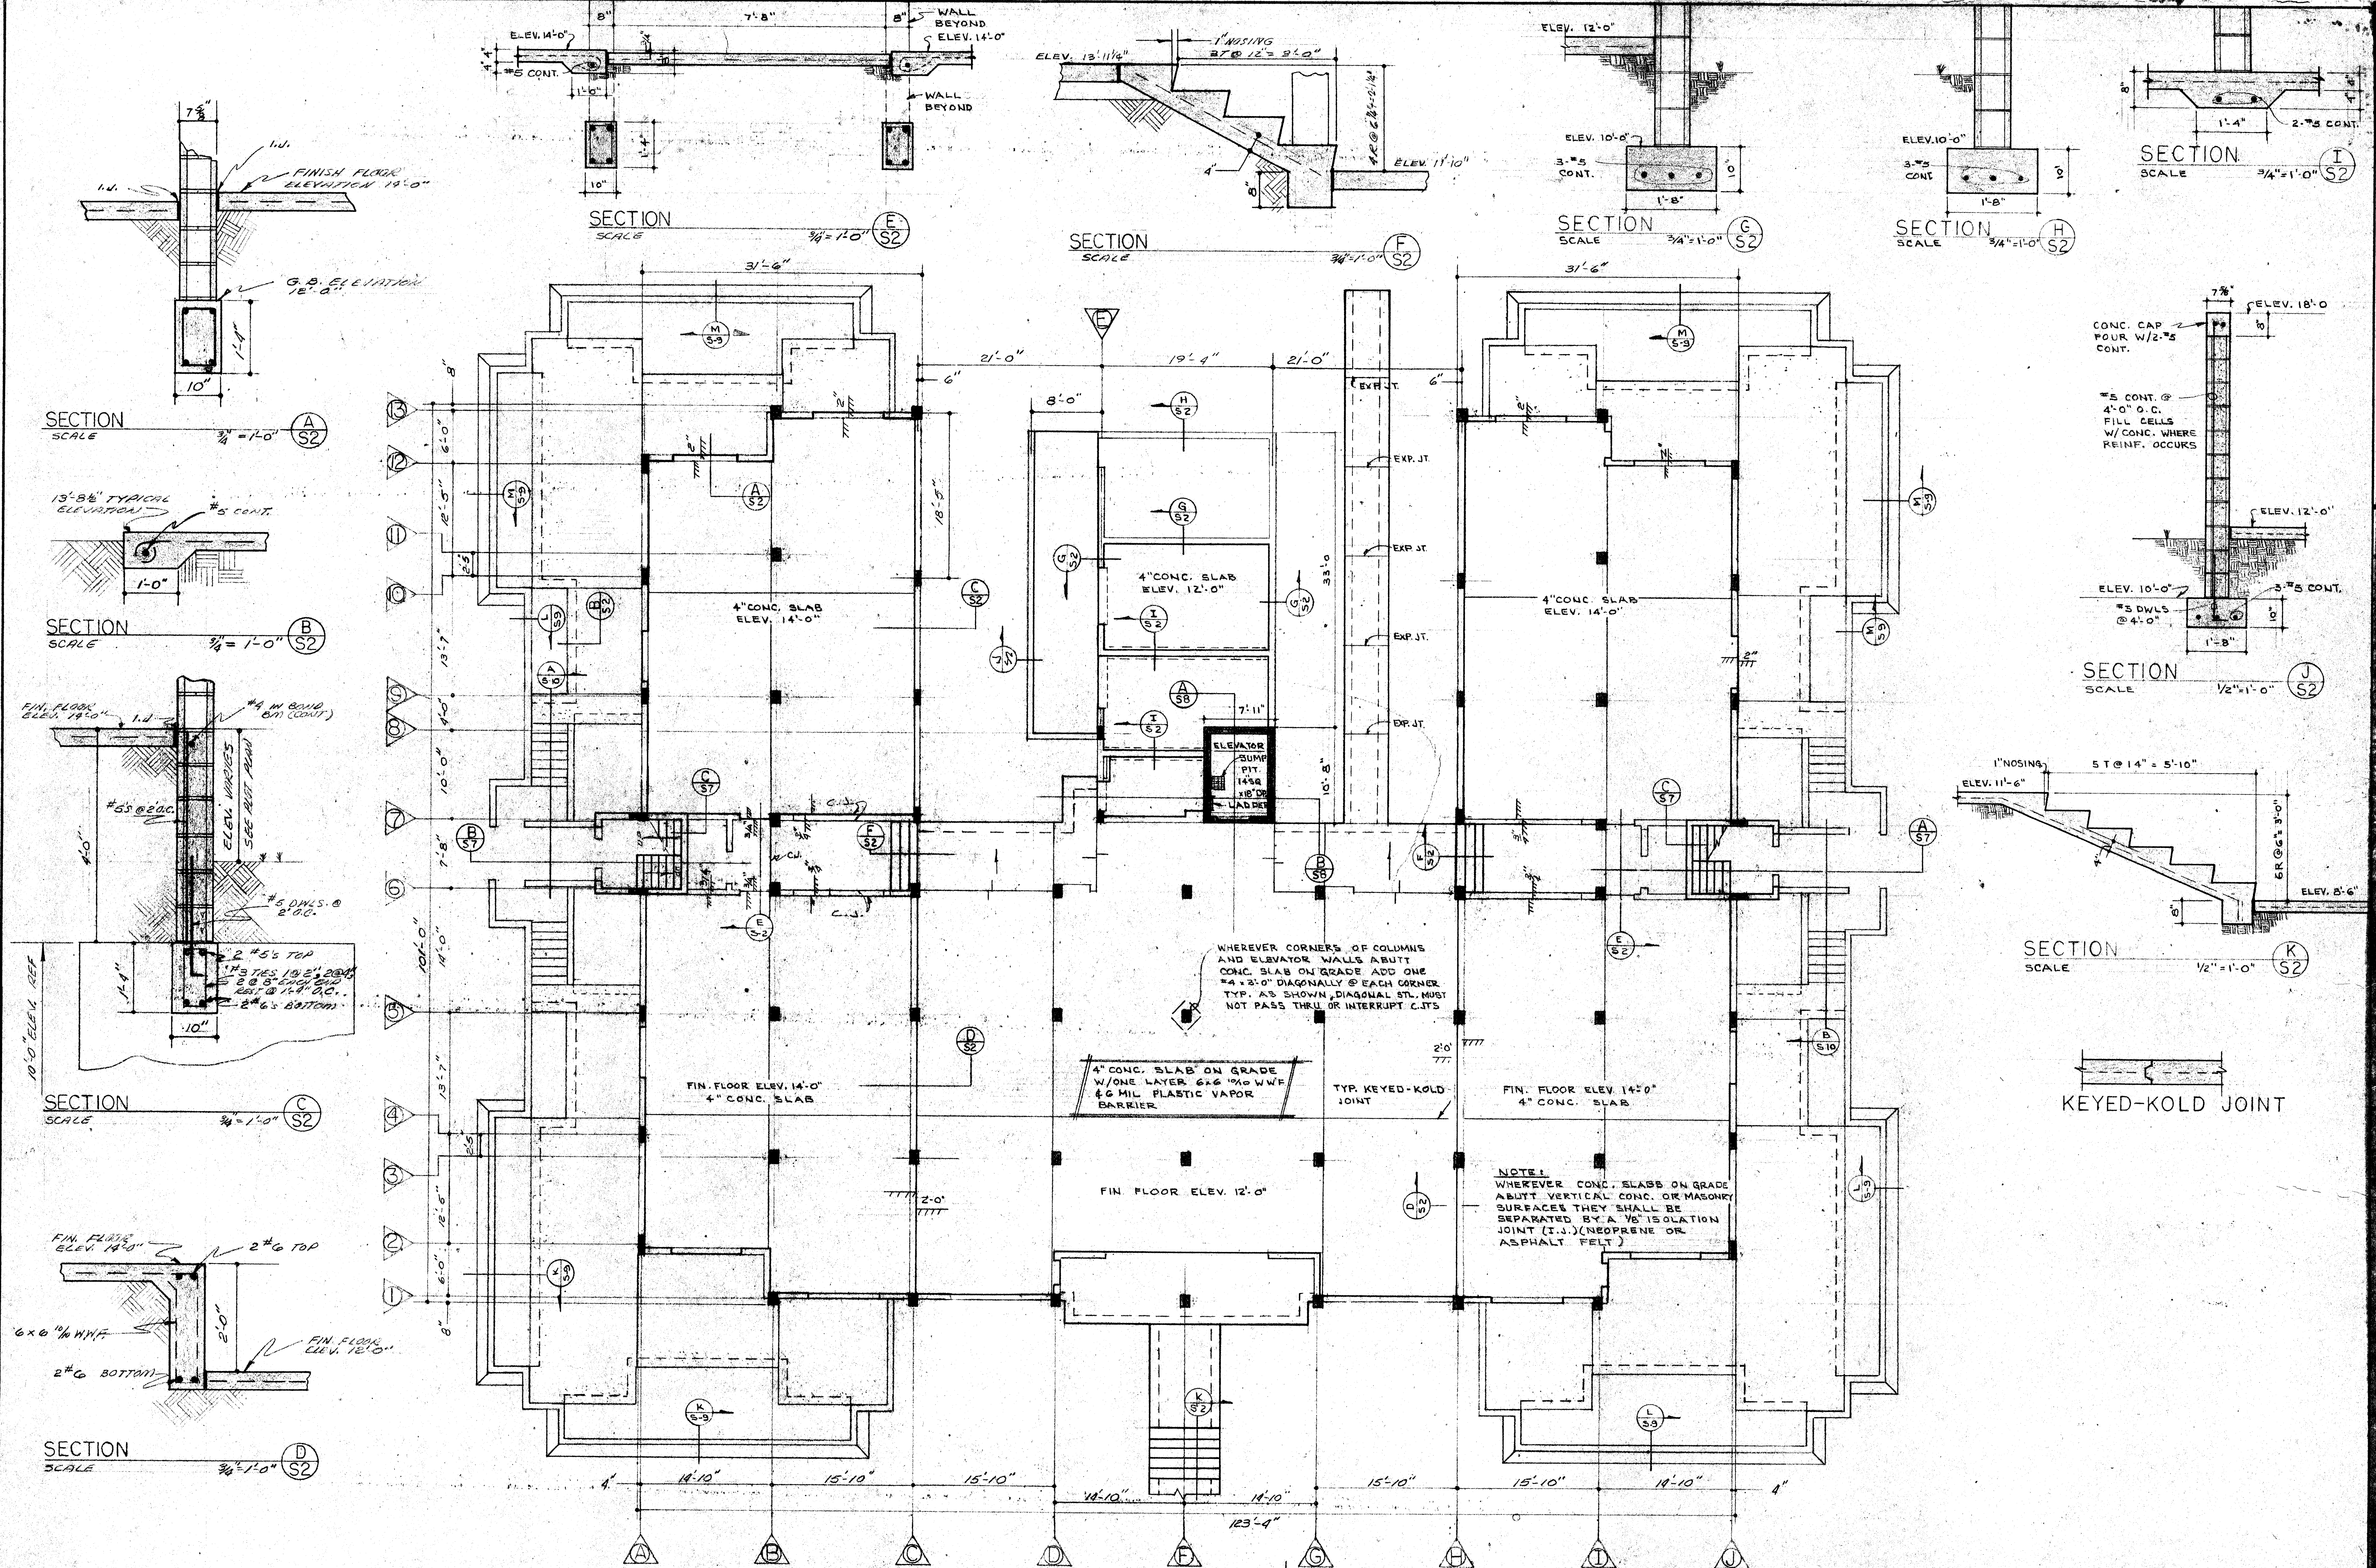
FIRST FLOOR PLAN
SCALE 1/8" = 1'-0"

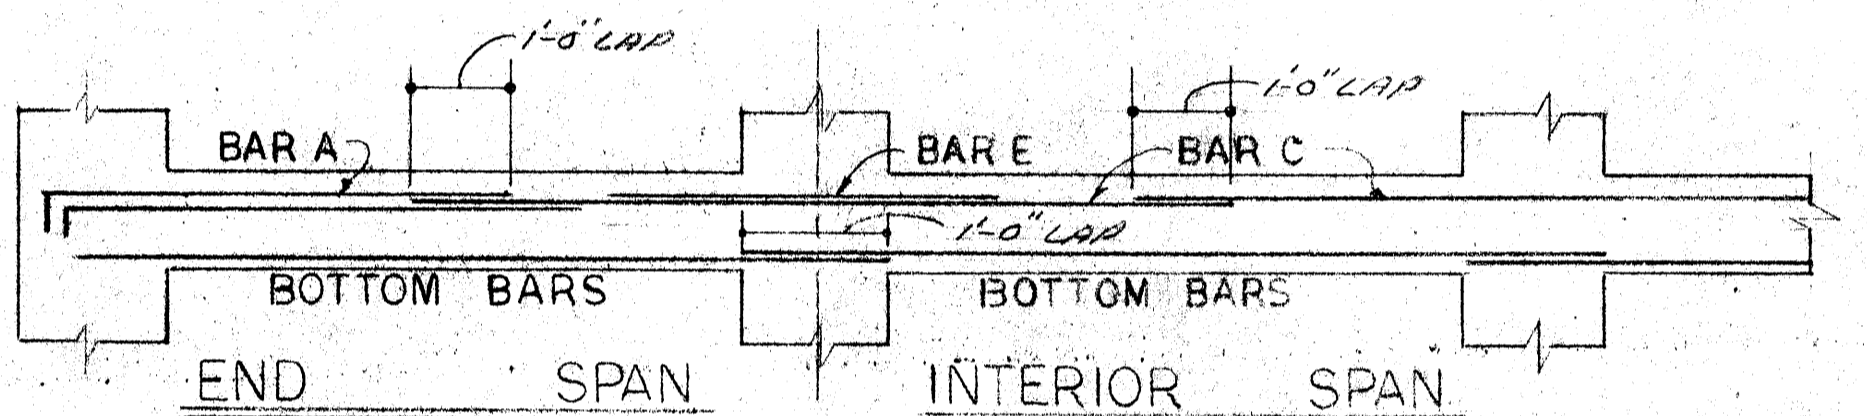
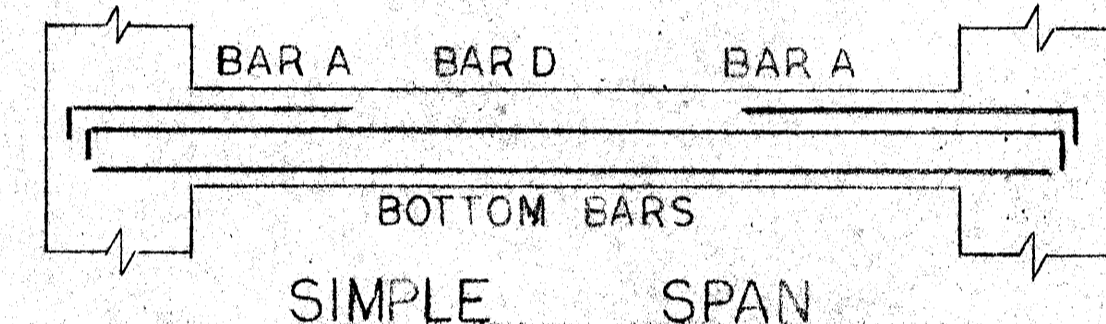
BAR LAPS
LAP COLUMN BARS BY DIA.
CONTINUED BARS AT FOUNDATION
30 DIA. LAP AT FOUNDATION
