PHASE I MILESTONE INSPECTION

The Riverview Condominium Association, Inc.

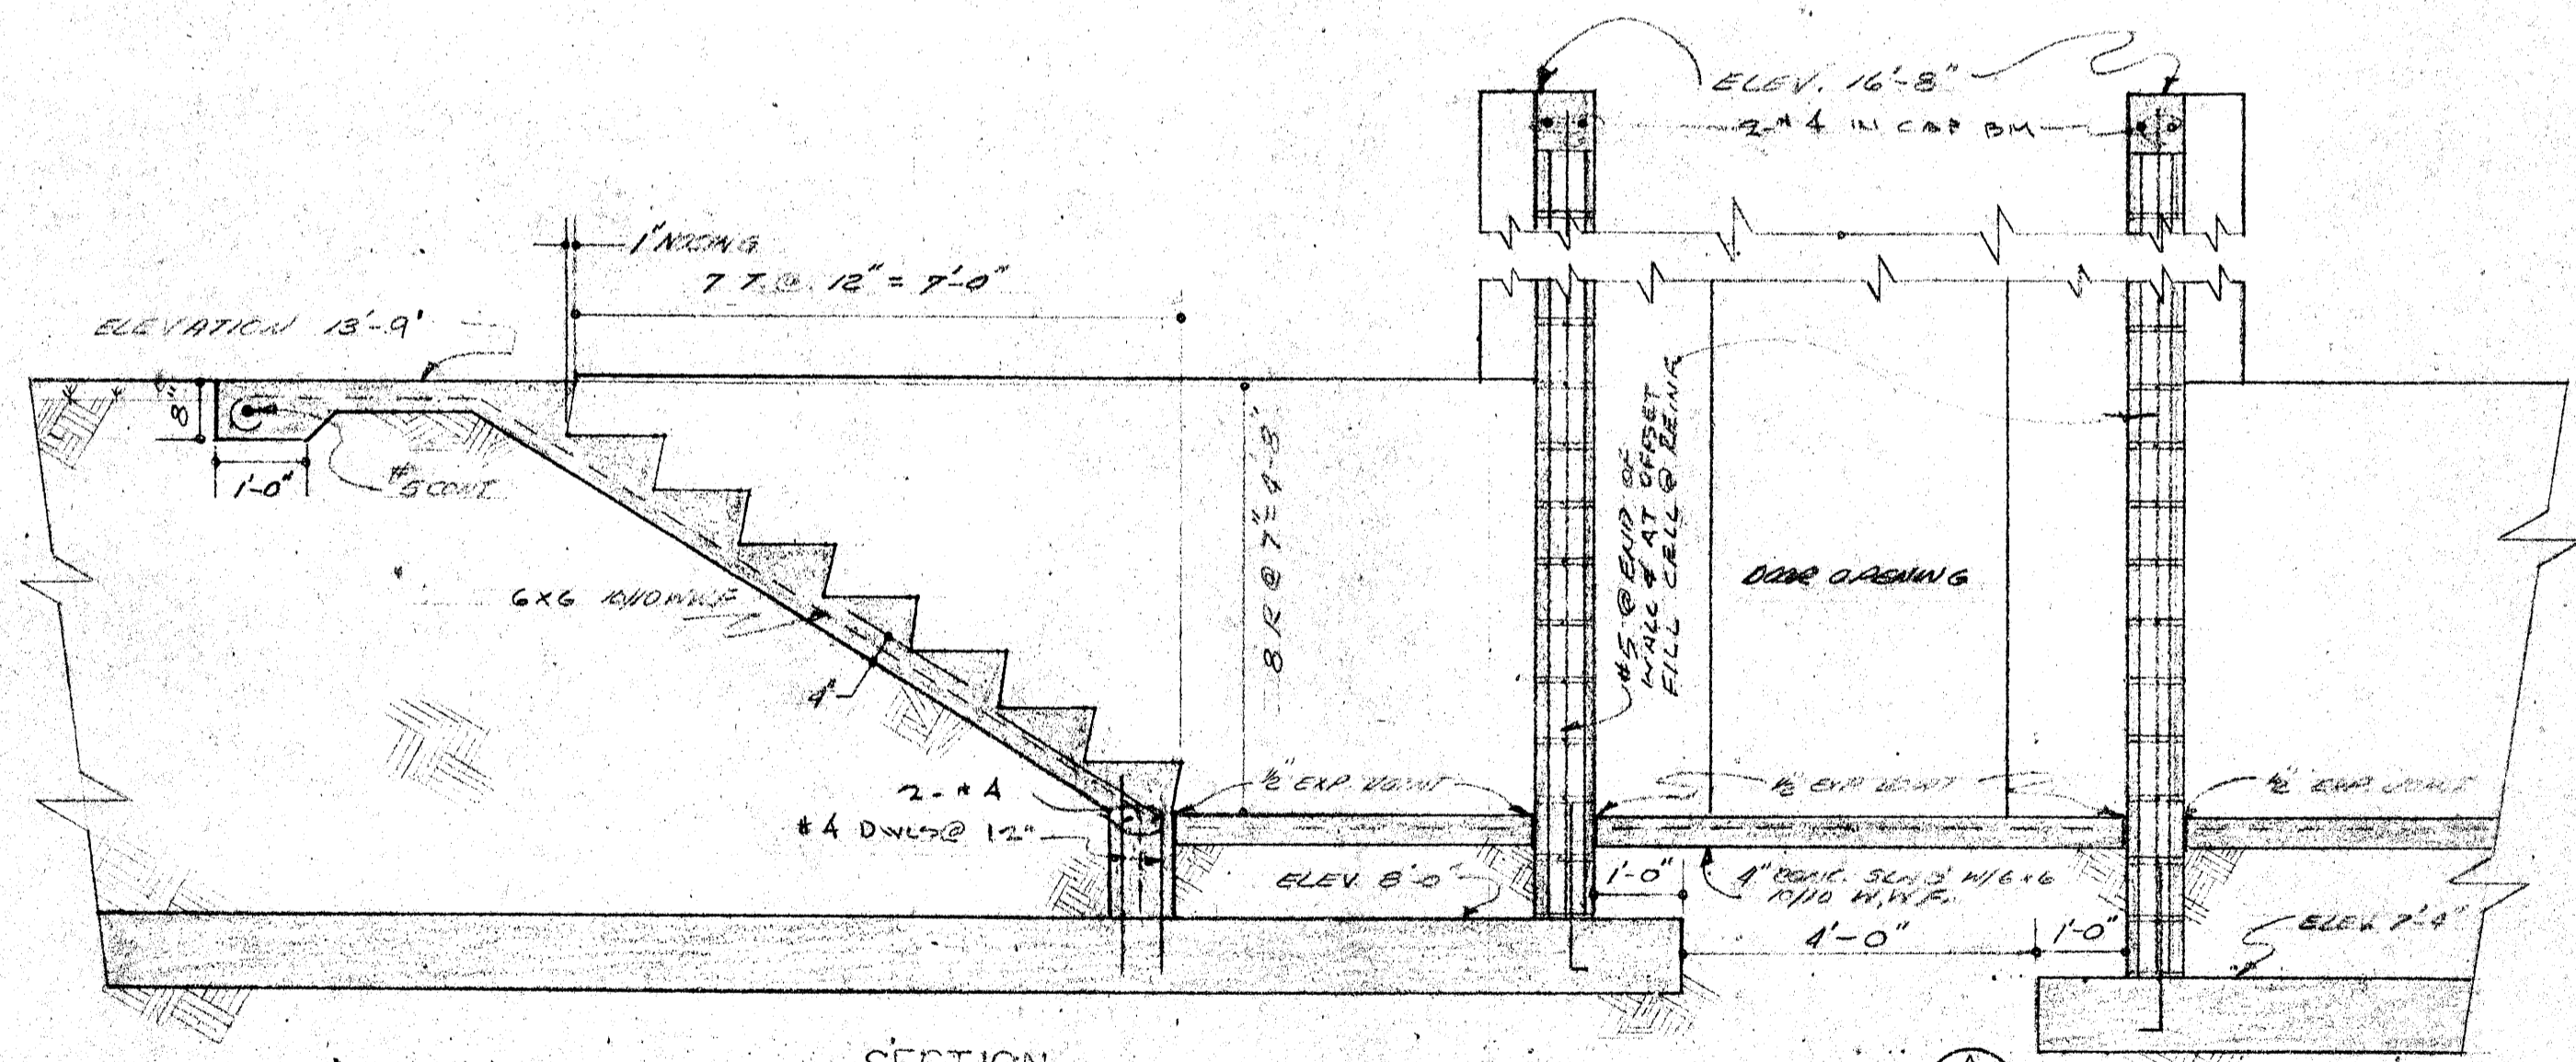
3. N. #1 @ 2"
4. TO ELEV. 16'-8"
2. TO 4. FL. #5 @ 12" ELEV.
FOUND. TO 2. FL. #3 @ 12" ELEV.

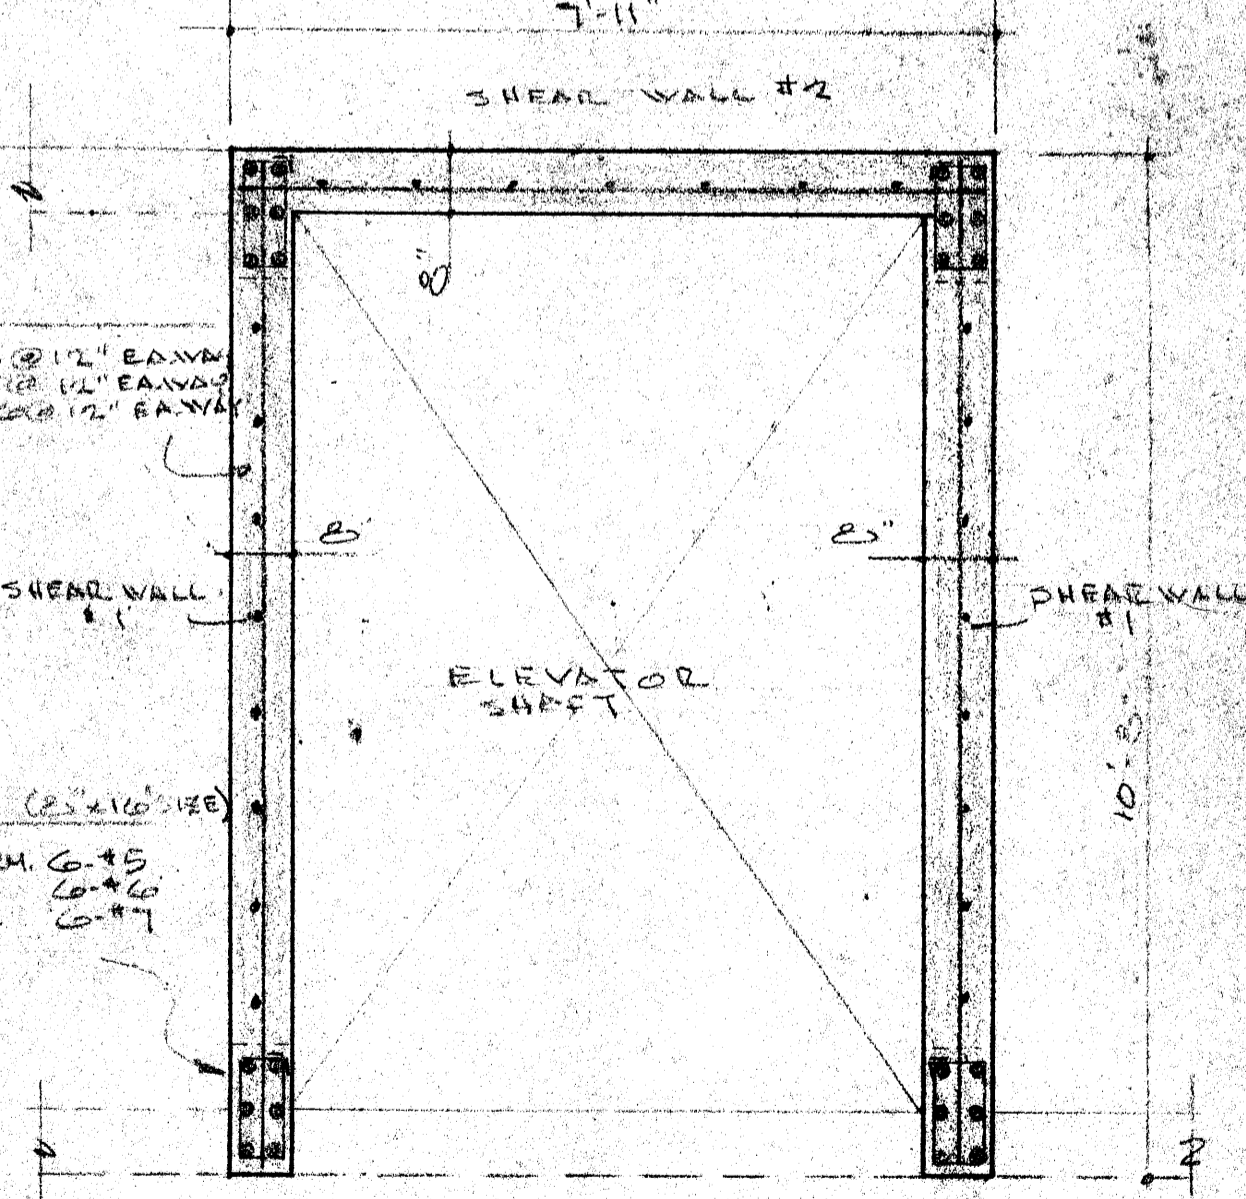
SHEAR WALL REINFORCEMENT
SCALE 1/2" = 1'-0"
CONC: 3,000 PSI f'c
STEEL: VERT. GRADE 60
HORIZ. GRADE 40
