# Windstorm Mitigation Report

The Riverview Condominium

Bradenton, FL

As of 9/12/2023 | FPAT File# MUD2320783

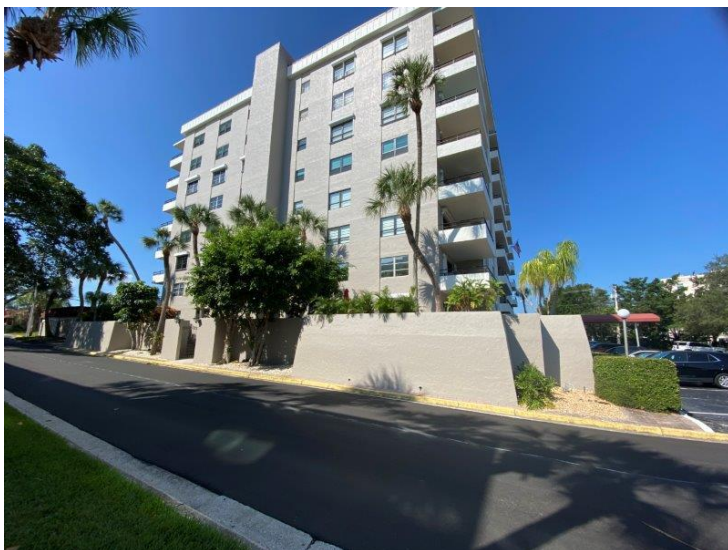
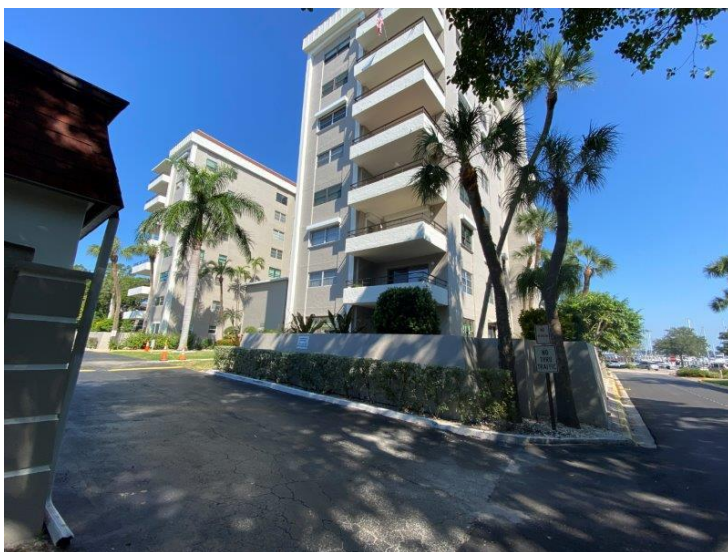
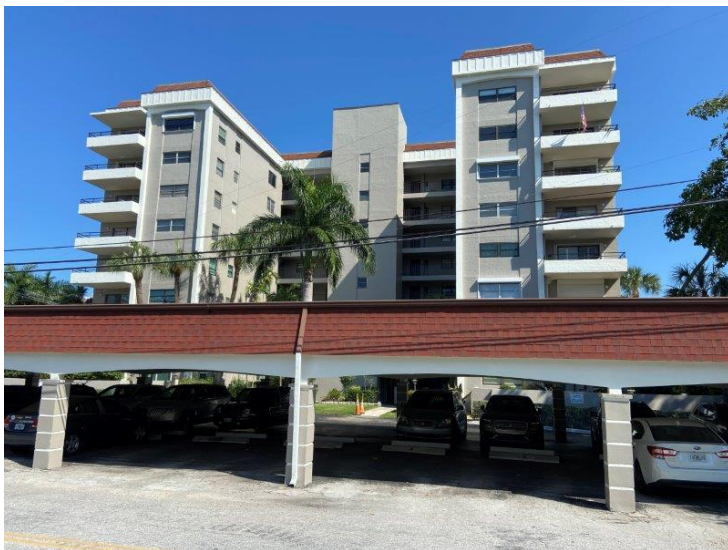
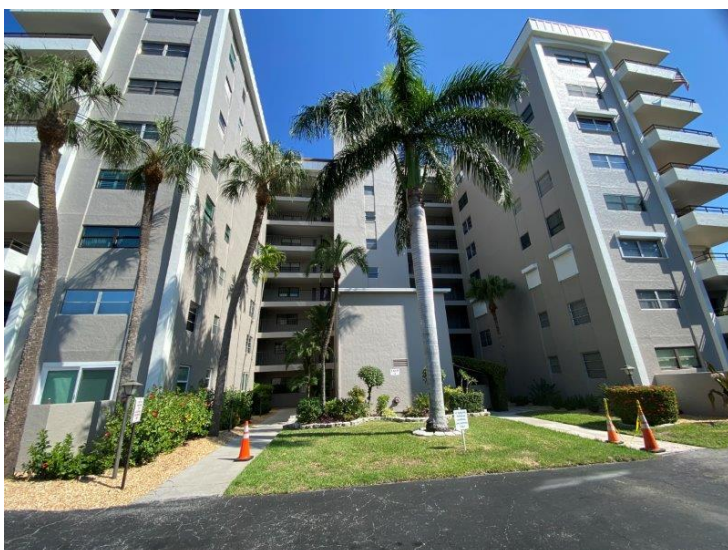
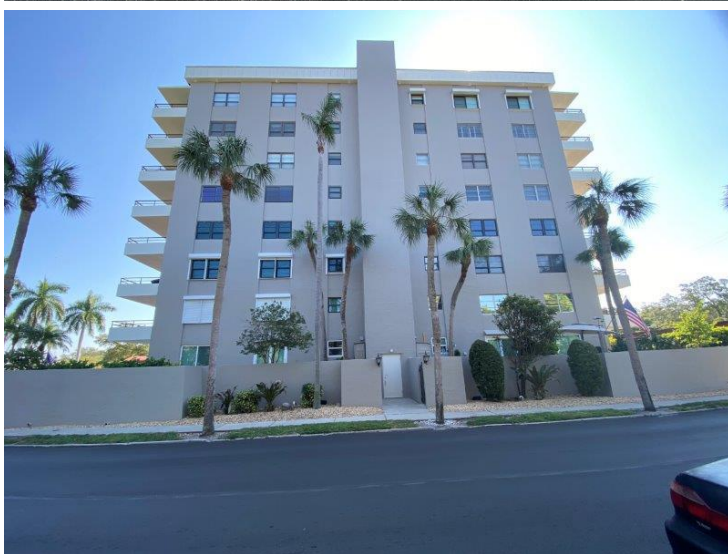
Exterior Elevation

- 7. Opening Protection:** **None or Some Glazed Openings**  
Comments: Inspection verified some metal shutter opening protection. Not all glazed openings were protected with impact resistant coverings

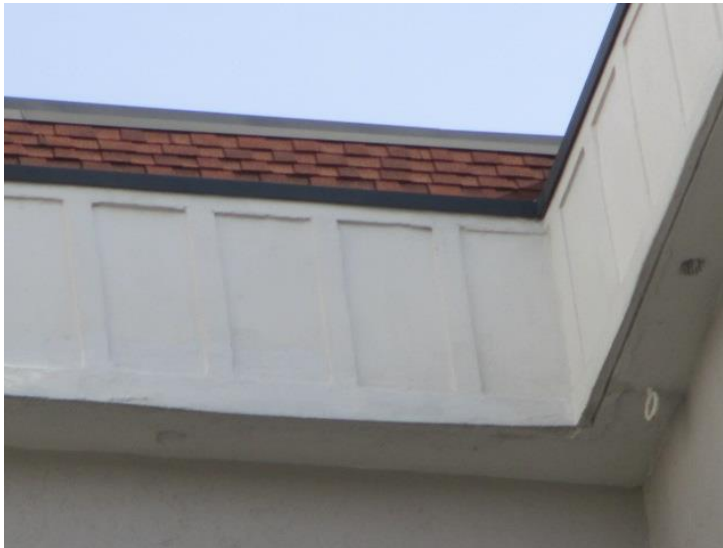
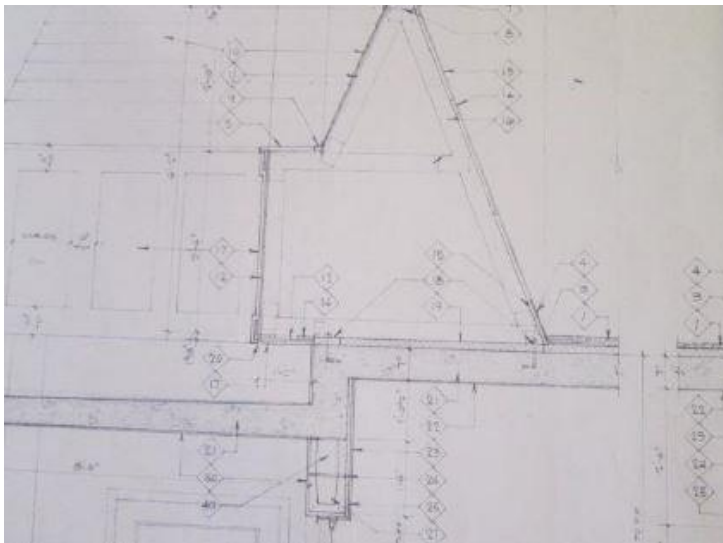
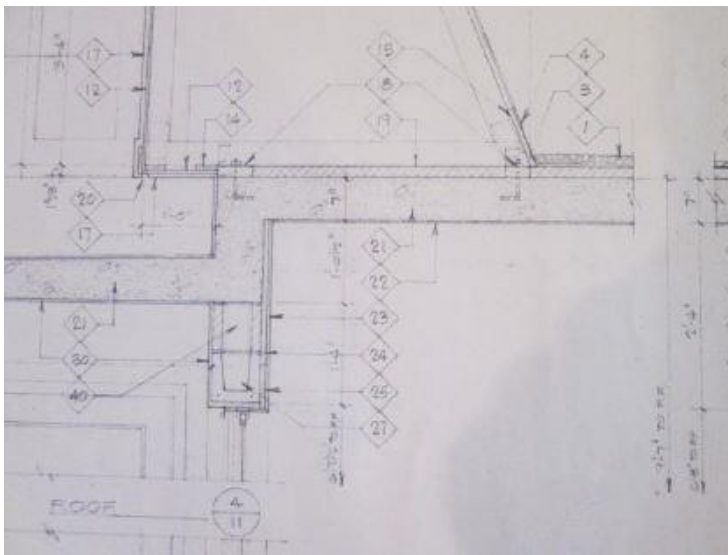
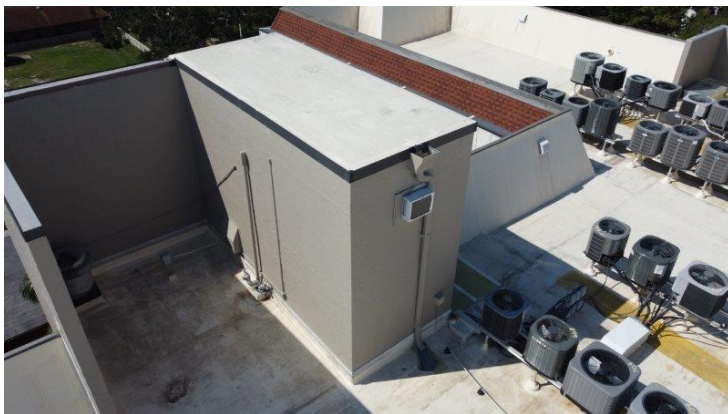
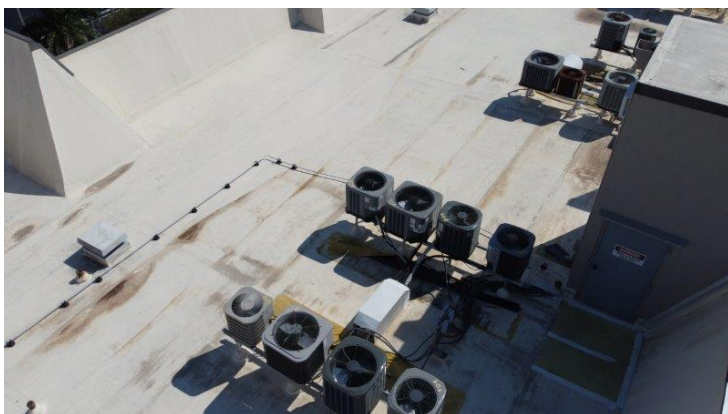
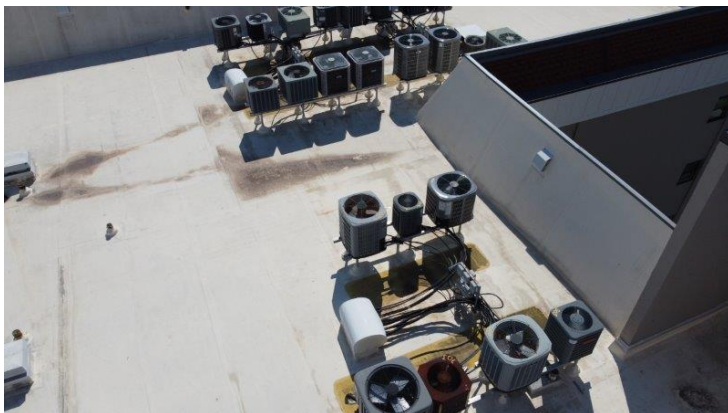
Roof Construction

- 3. Roof Deck Attachment:** **Reinforced Concrete Roof Deck**  
Comments: Inspection verified a roof structure composed of cast-in-place or pre-cast structural concrete designed to be self supporting and integrally attached to the wall / support system.

- 4. Roof to Wall Attachment:** **Structural**  
Comments: Inspection verified a roof structure composed of cast-in-place or pre-cast structural concrete designed to be self supporting and integrally attached to the wall / support system.

- 5. Roof Geometry:** **Flat Roof**  
Comments: Inspection verified a flat roof shape.
- 6. SWR:** **No**  
Comments: Secondary water resistance does not apply to concrete roof decks.

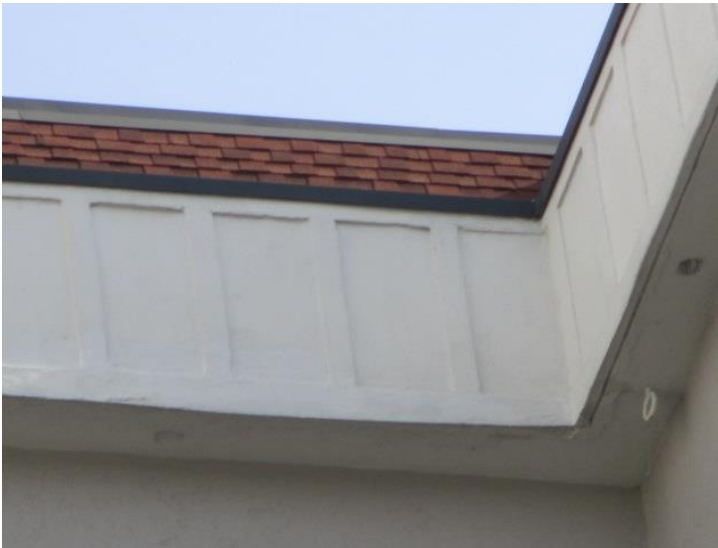
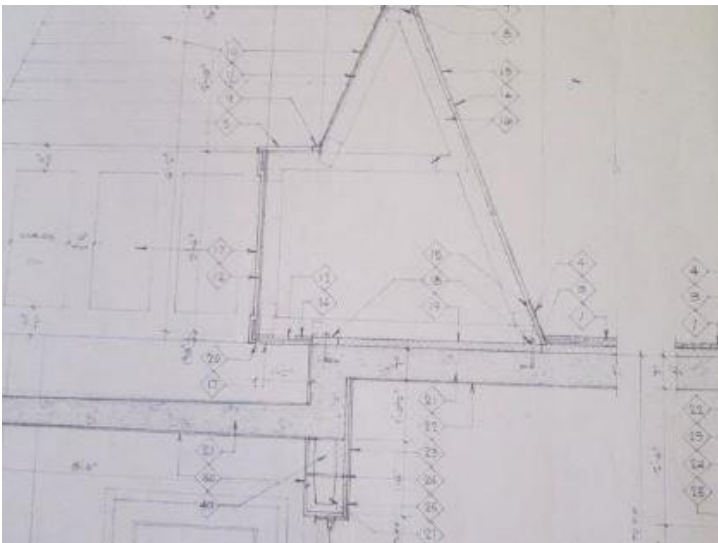
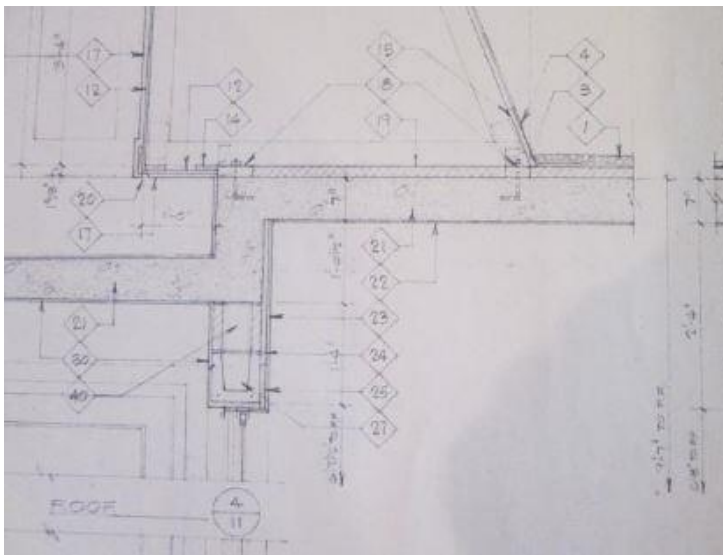
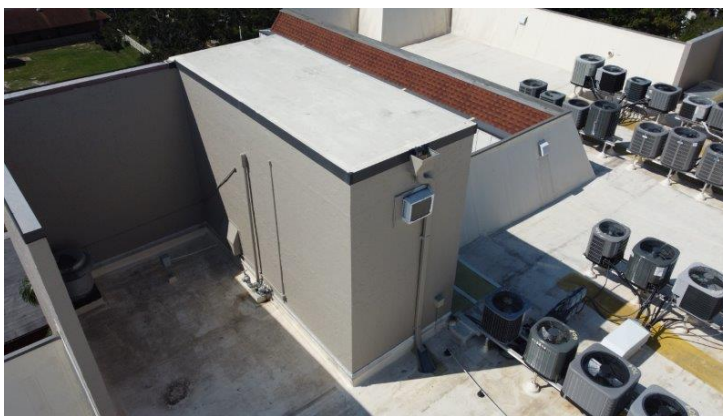
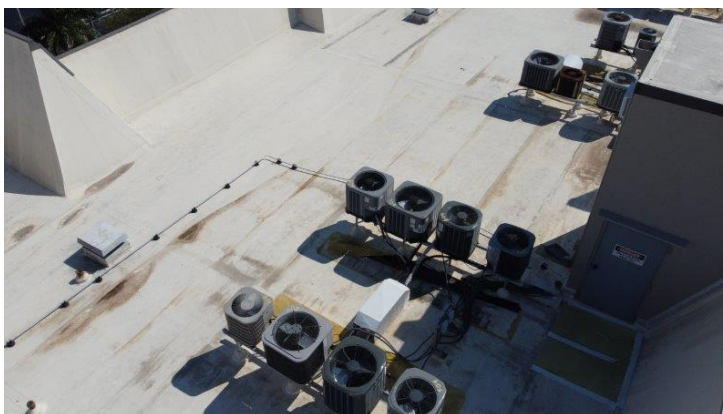
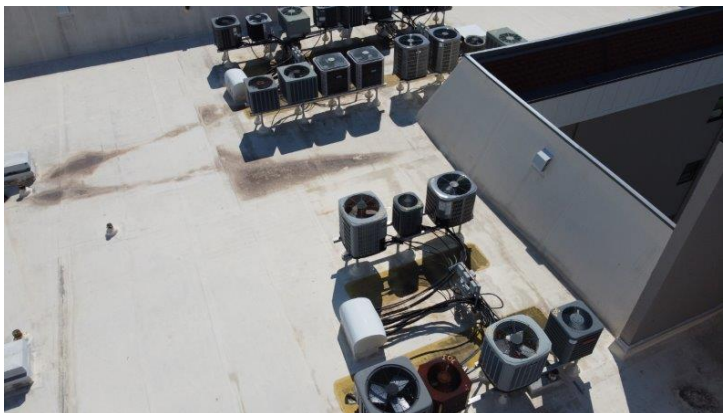
Roof Construction

- 1. Roof Covering:** **FBC Equivalent**  
Comments: The roof covering was replaced in 2013. The roof permit was confirmed and the permit number is RF.13.05676. This roof was verified as meeting the building code requirements outlined on the mitigation affidavit.
- 2. Roof Deck Attachment:** **Reinforced Concrete Roof Deck**  
Comments: Inspection verified a roof structure composed of cast-in-place or pre-cast structural concrete designed to be self supporting and integrally attached to the wall / support system.
- 3. SWR:** **No**  
Comments: Secondary water resistance does not apply to concrete roof decks.
- 4. Opening Protection:** **None or Some Glazed Openings**  
Comments: Inspection verified some metal shutter opening protection. Not all glazed openings were protected with impact resistant coverings
